Mutiny Bay Boat Ramp Historical Observations

The objective of this presentation is to show how Mutiny bay has change over the last 20 years and illustrate how the counties dredging operations to maintain the boat ramp is adversely effecting the bays ecosystem.

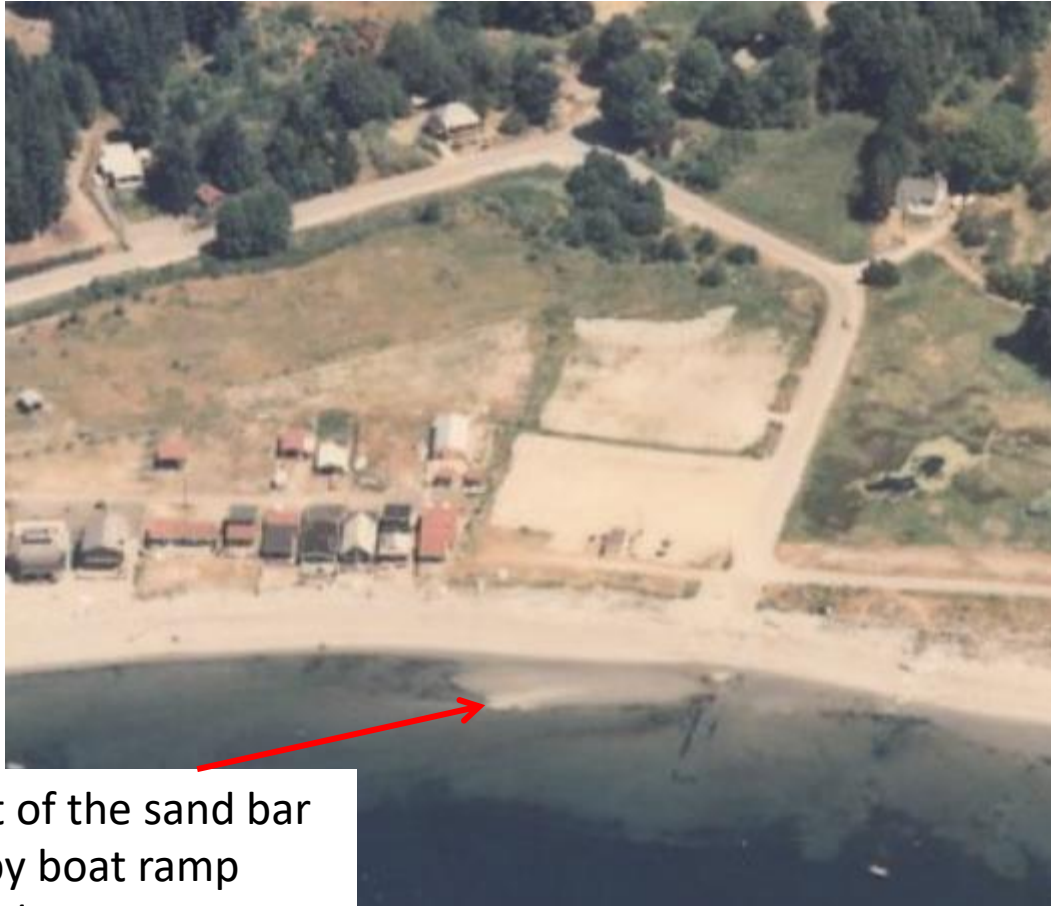
Mutiny Bay 1977

The photo does show the outline of the boat ramp with some sand on the down drift side. The boat ramp went through regular cleaning to keep it open.

The start of the sand bar
caused by boat ramp
cleaning /dredging

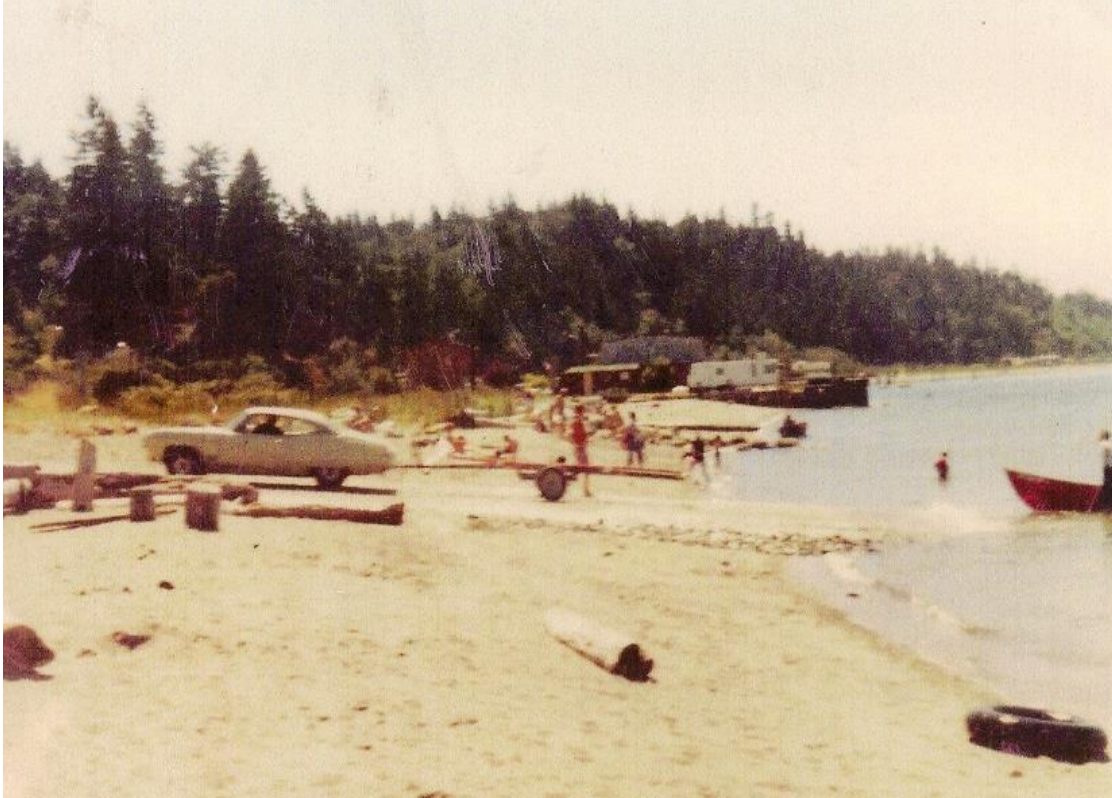
Mutiny Bay 1980

The following picture is of the boat ramp in 1980s just after it was raised 3 feet. A step up was required to get over the ramp. There are no piles of sand just a flat beach.

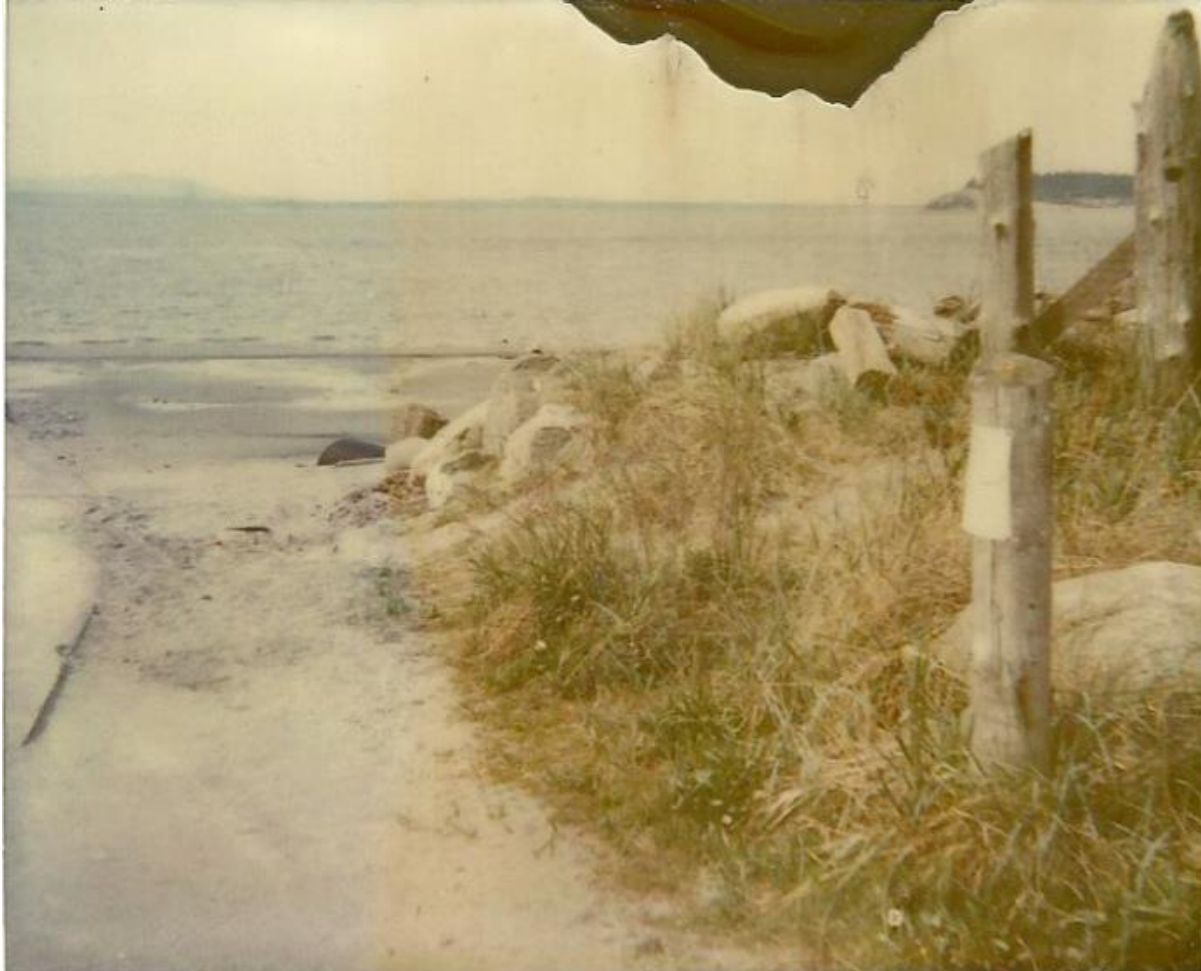
Boat ramp 1980

In the 1980s the boat ramp did not require much cleaning. You can see the top of the drain culvert which allow easy maintenance to keep it open. To day it is under 8 -10 feet of sand

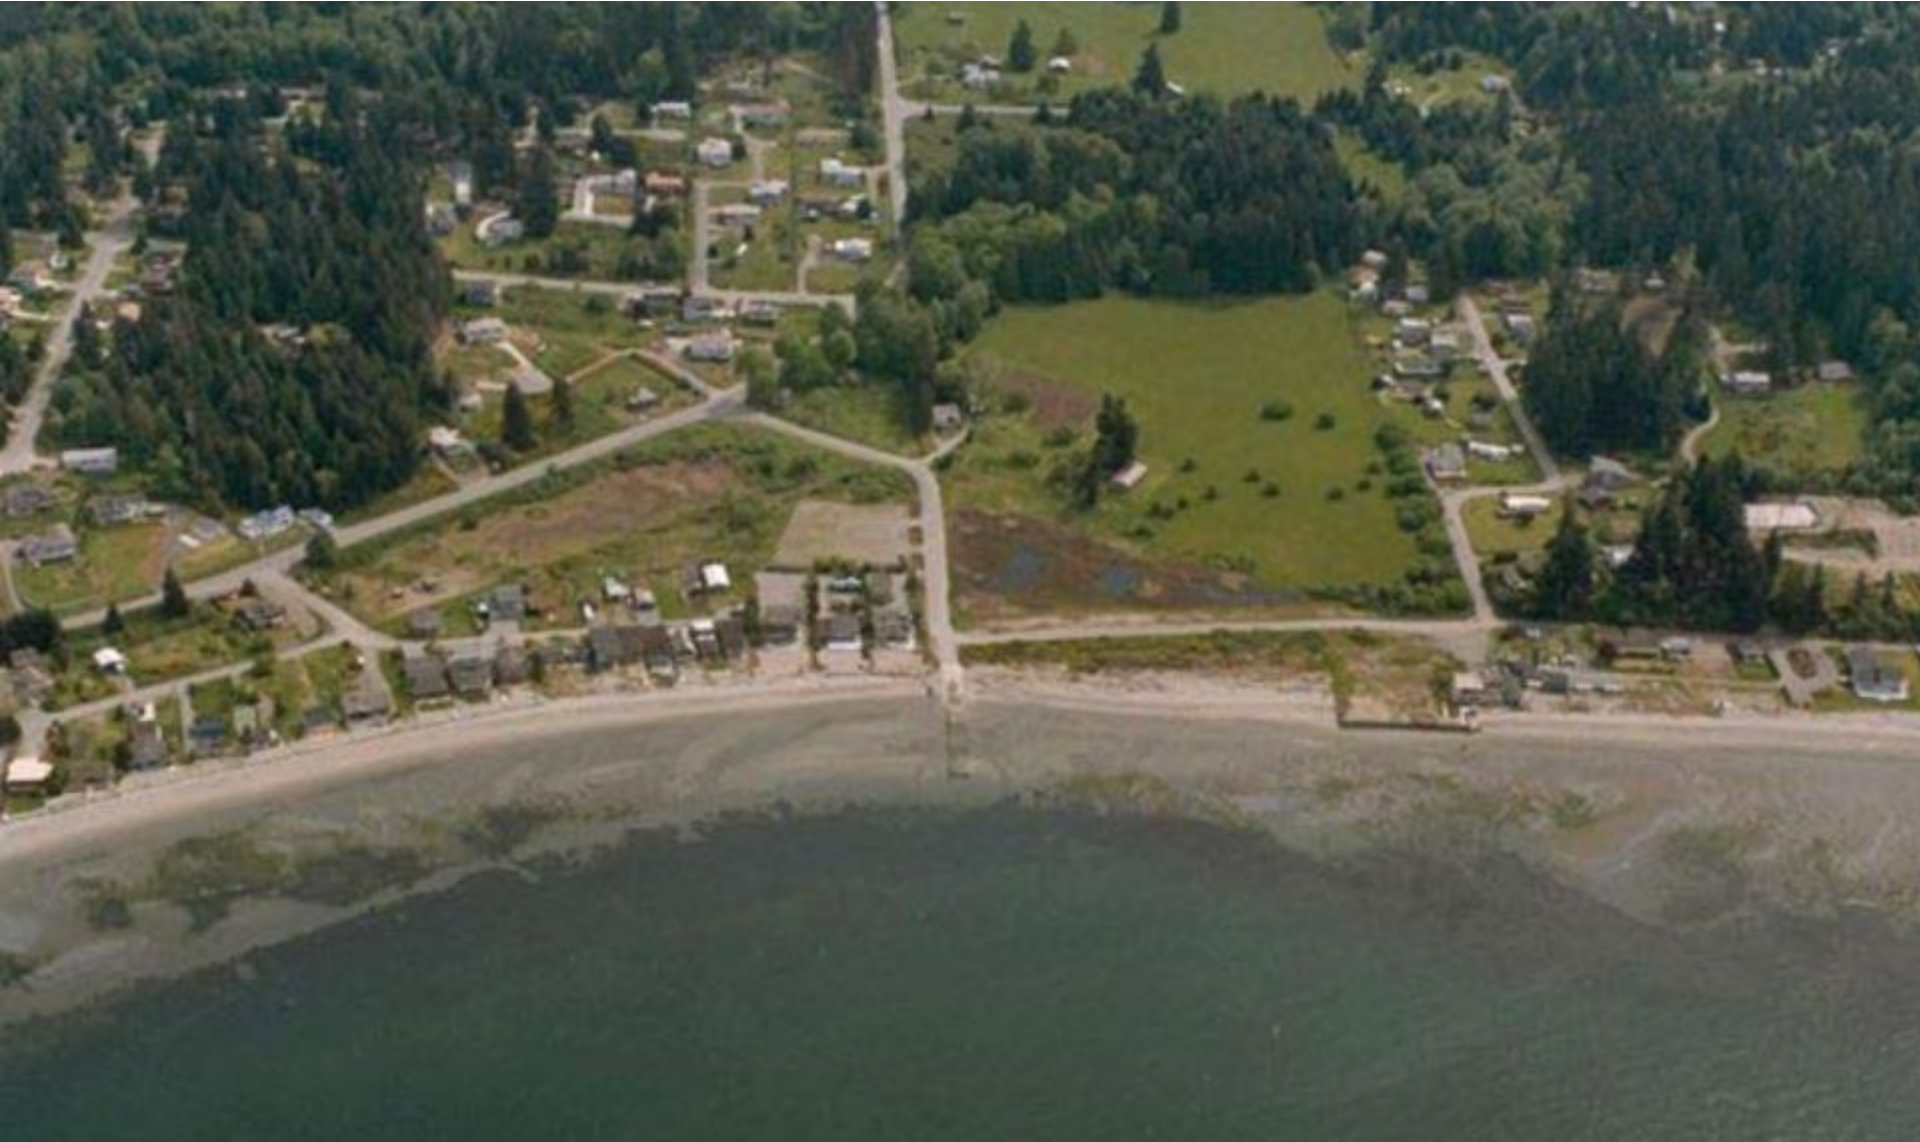
Mutiny Bay 1993

In 1993 the beach line around the boat ramp has not changed much. No big piles of sand along side the boat ramp and not much evidence of a sand bar .

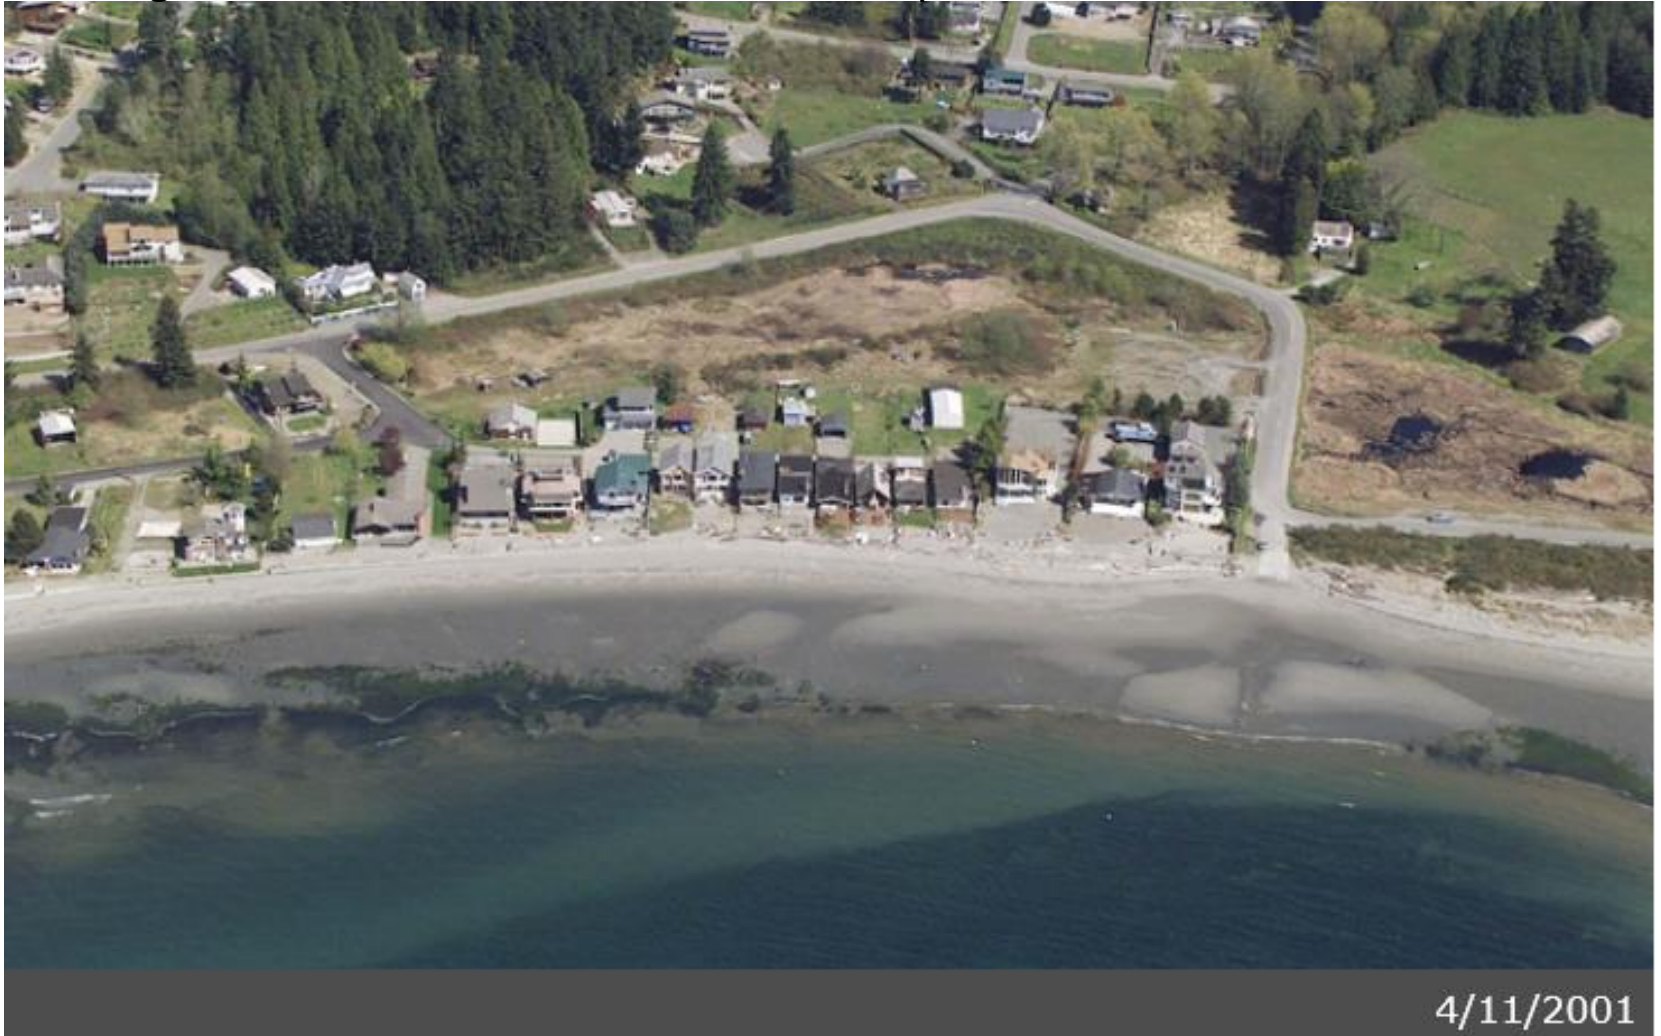
Mutiny Bay 2001

This Aerial picture clearly shows the effect of continued cleaning/dredging of the boat ramp. Here is the first evidence of the problem with sand bars starting to form on both sides of the boat ramp

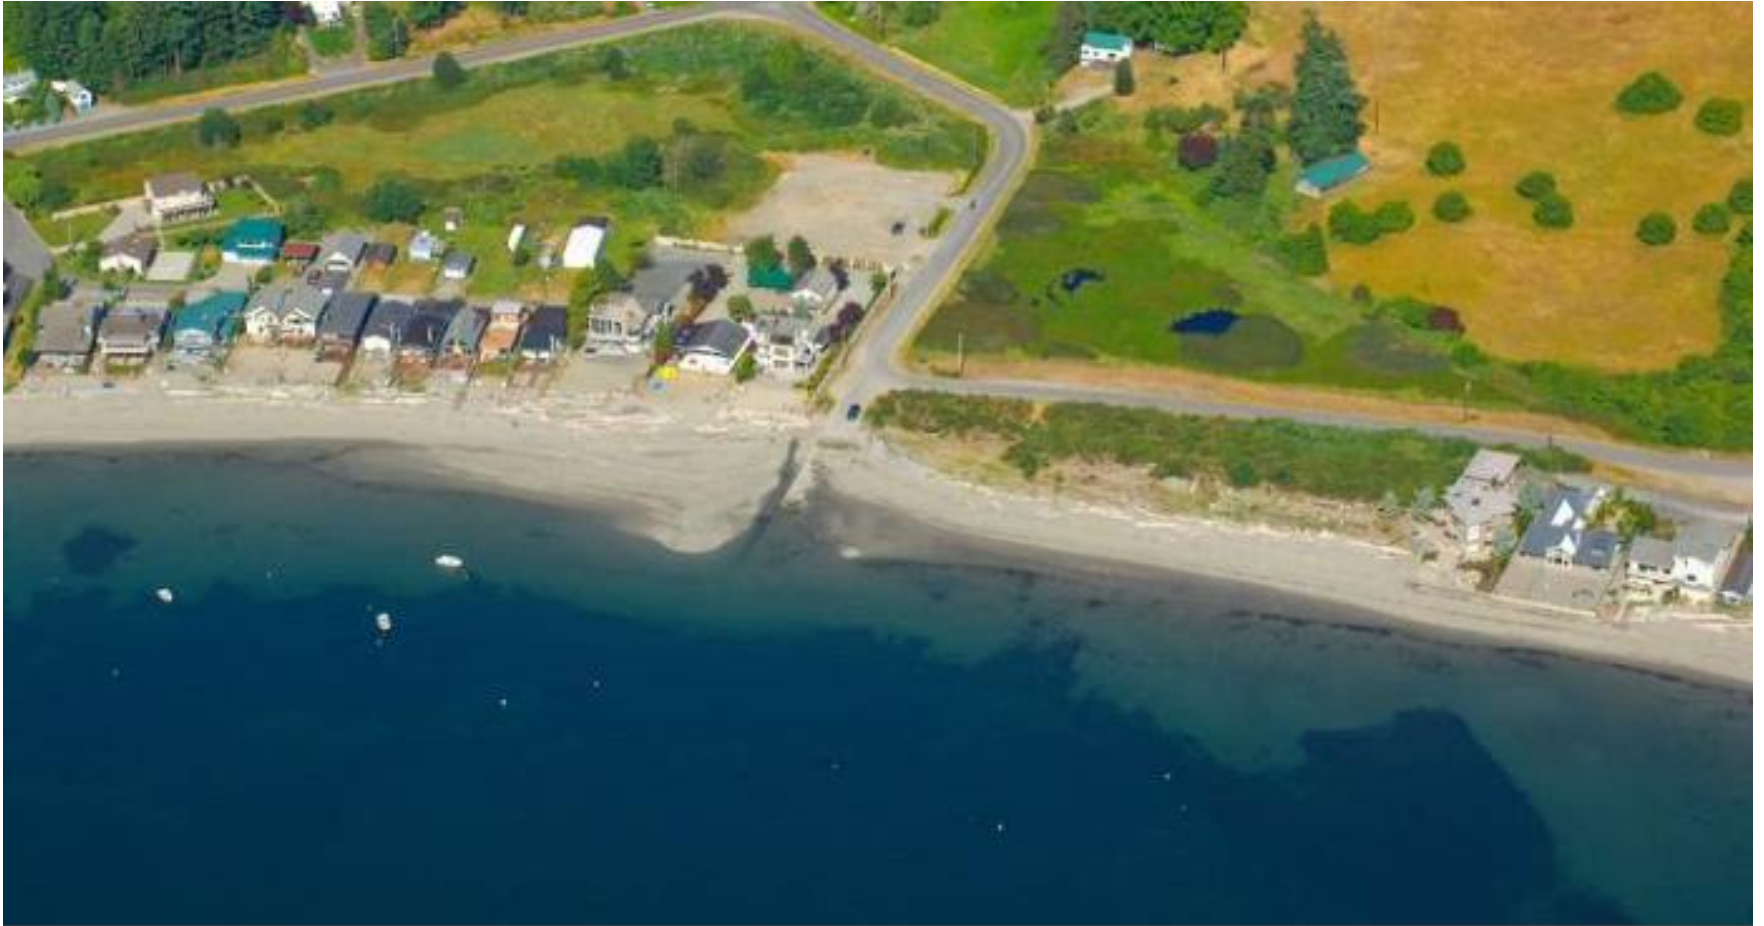
Mutiny Bay 2006

This Aerial picture clearly shows the effect of continued cleaning/dredging of the boat ramp. The sand bar has grown significantly in 5 years of continued boat ramp cleaning/dredging operations

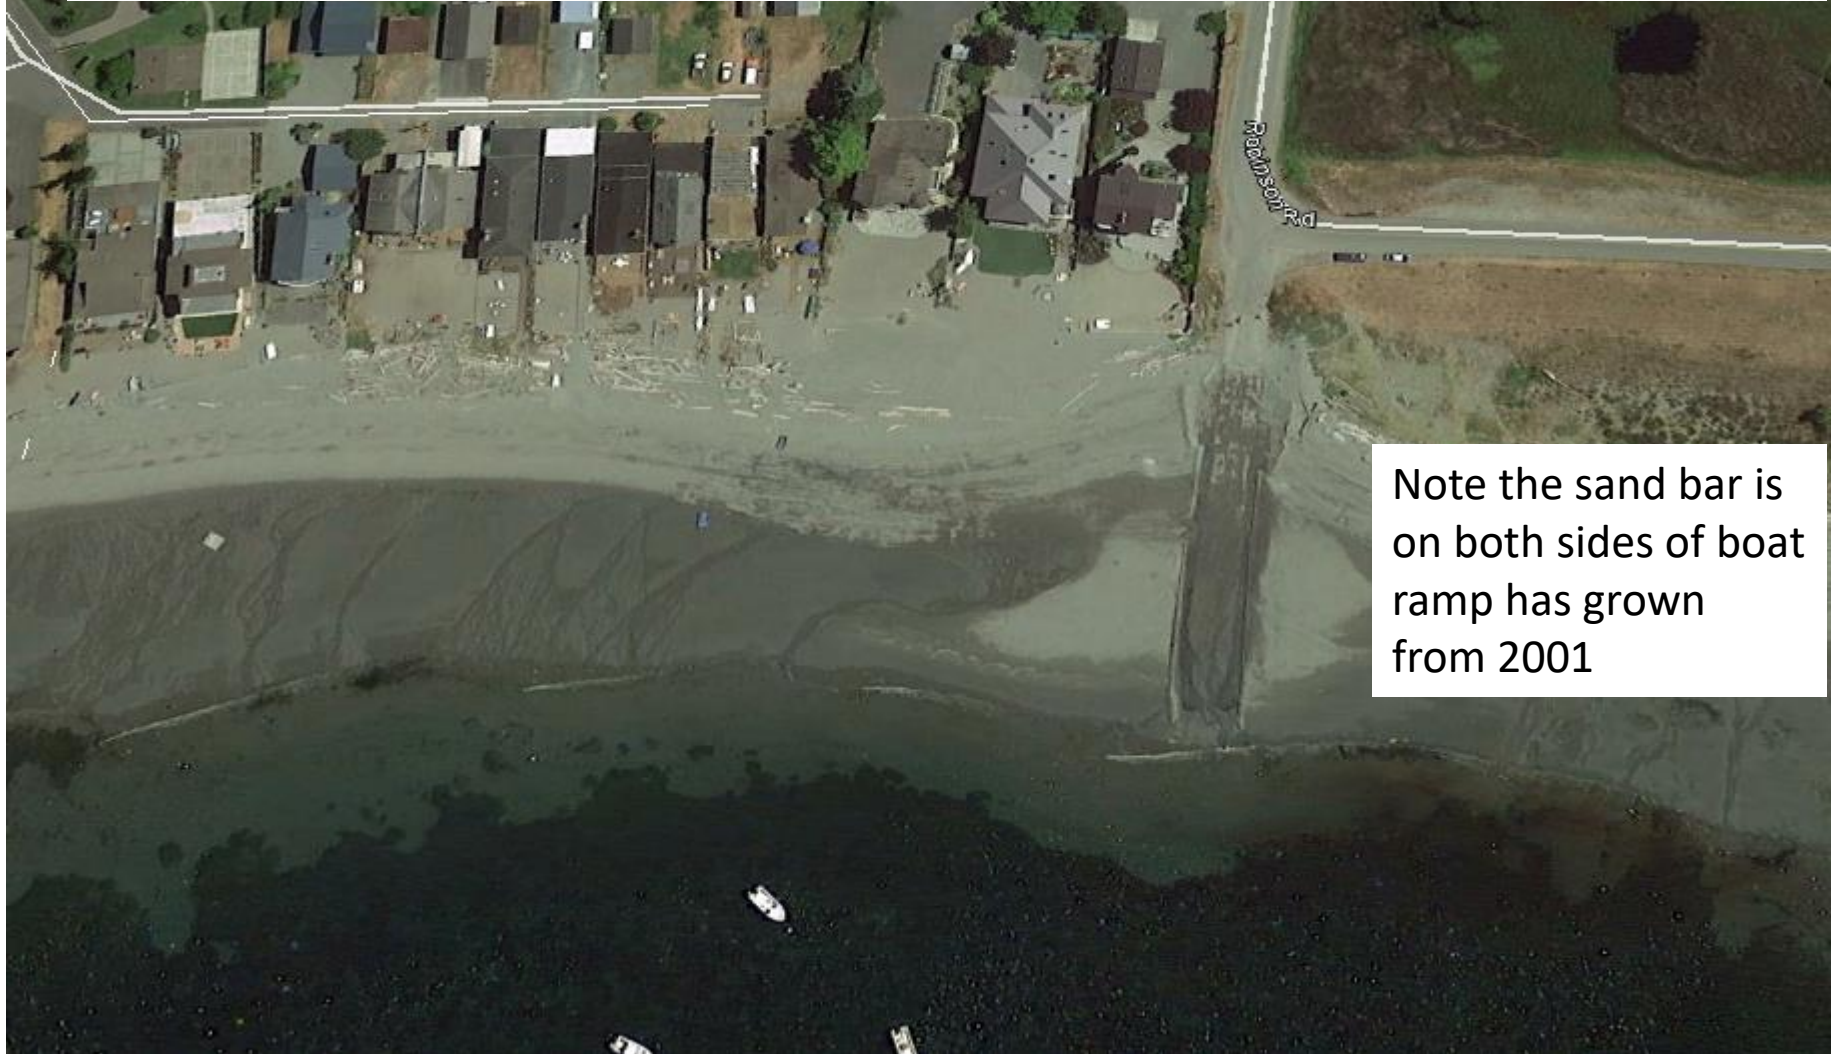
Mutiny Bay 2014 Google Earth

It is Hard to see changes from 2006 to 2014. The real indicator is the Driftwood line has migrated towards the new high water mark. Later sides show this migration

Note the sand bar is on both sides of boat ramp has grown from 2001

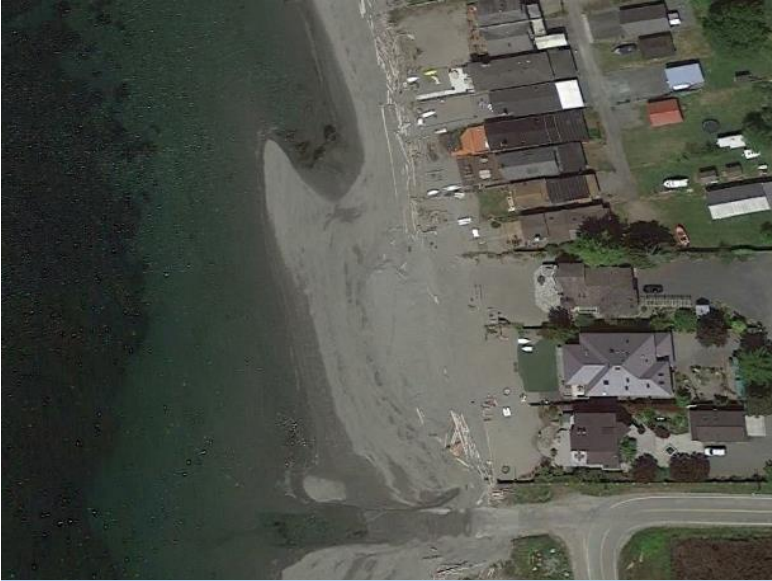
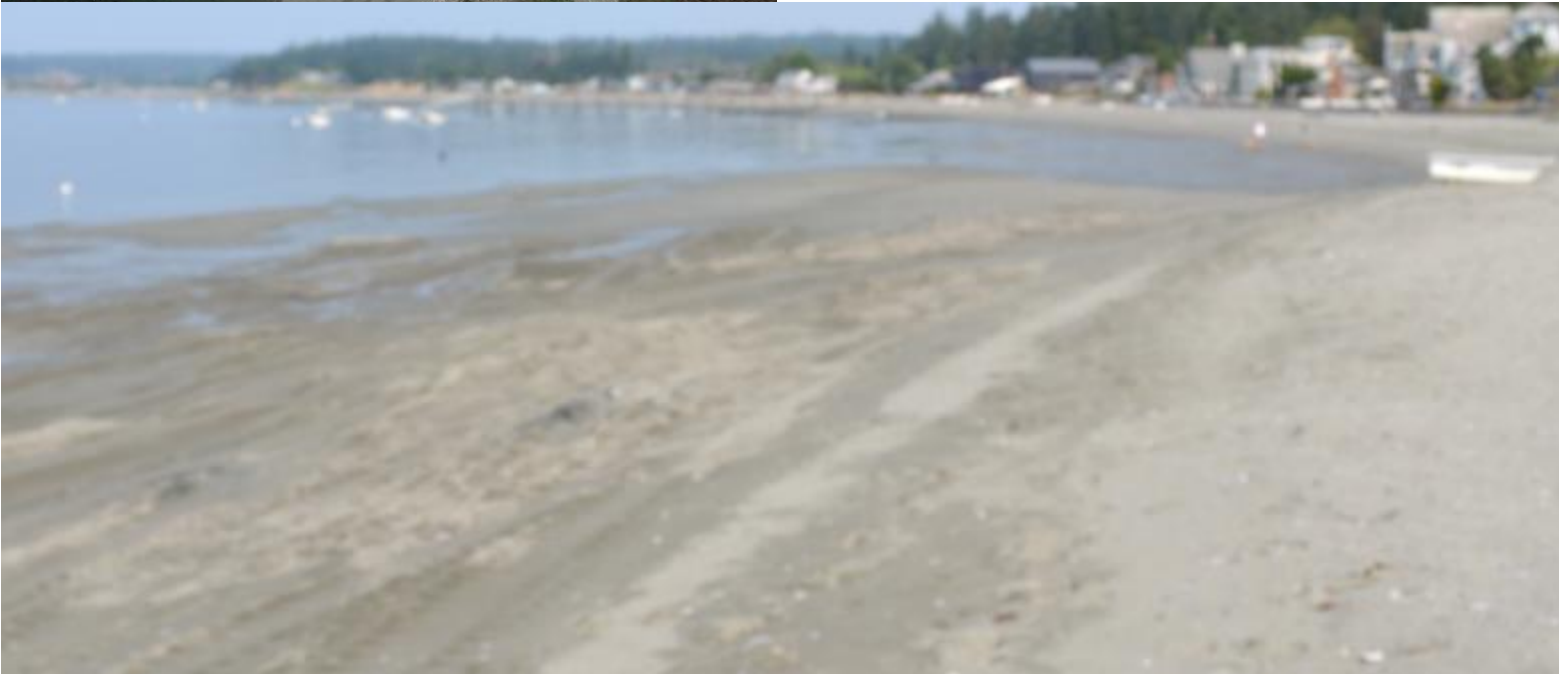
Mutiny Bay 2017 Google Earth

The 2017 Google Earth photo clearly shows the sand bar created by Island Counties dredging operation the second photo is not as clear but shows the tire prints of the front end loader as it adds dredged sediment to the sand bay, Looking north you can see the homes where the shoreline is being eroded away by the sand bar

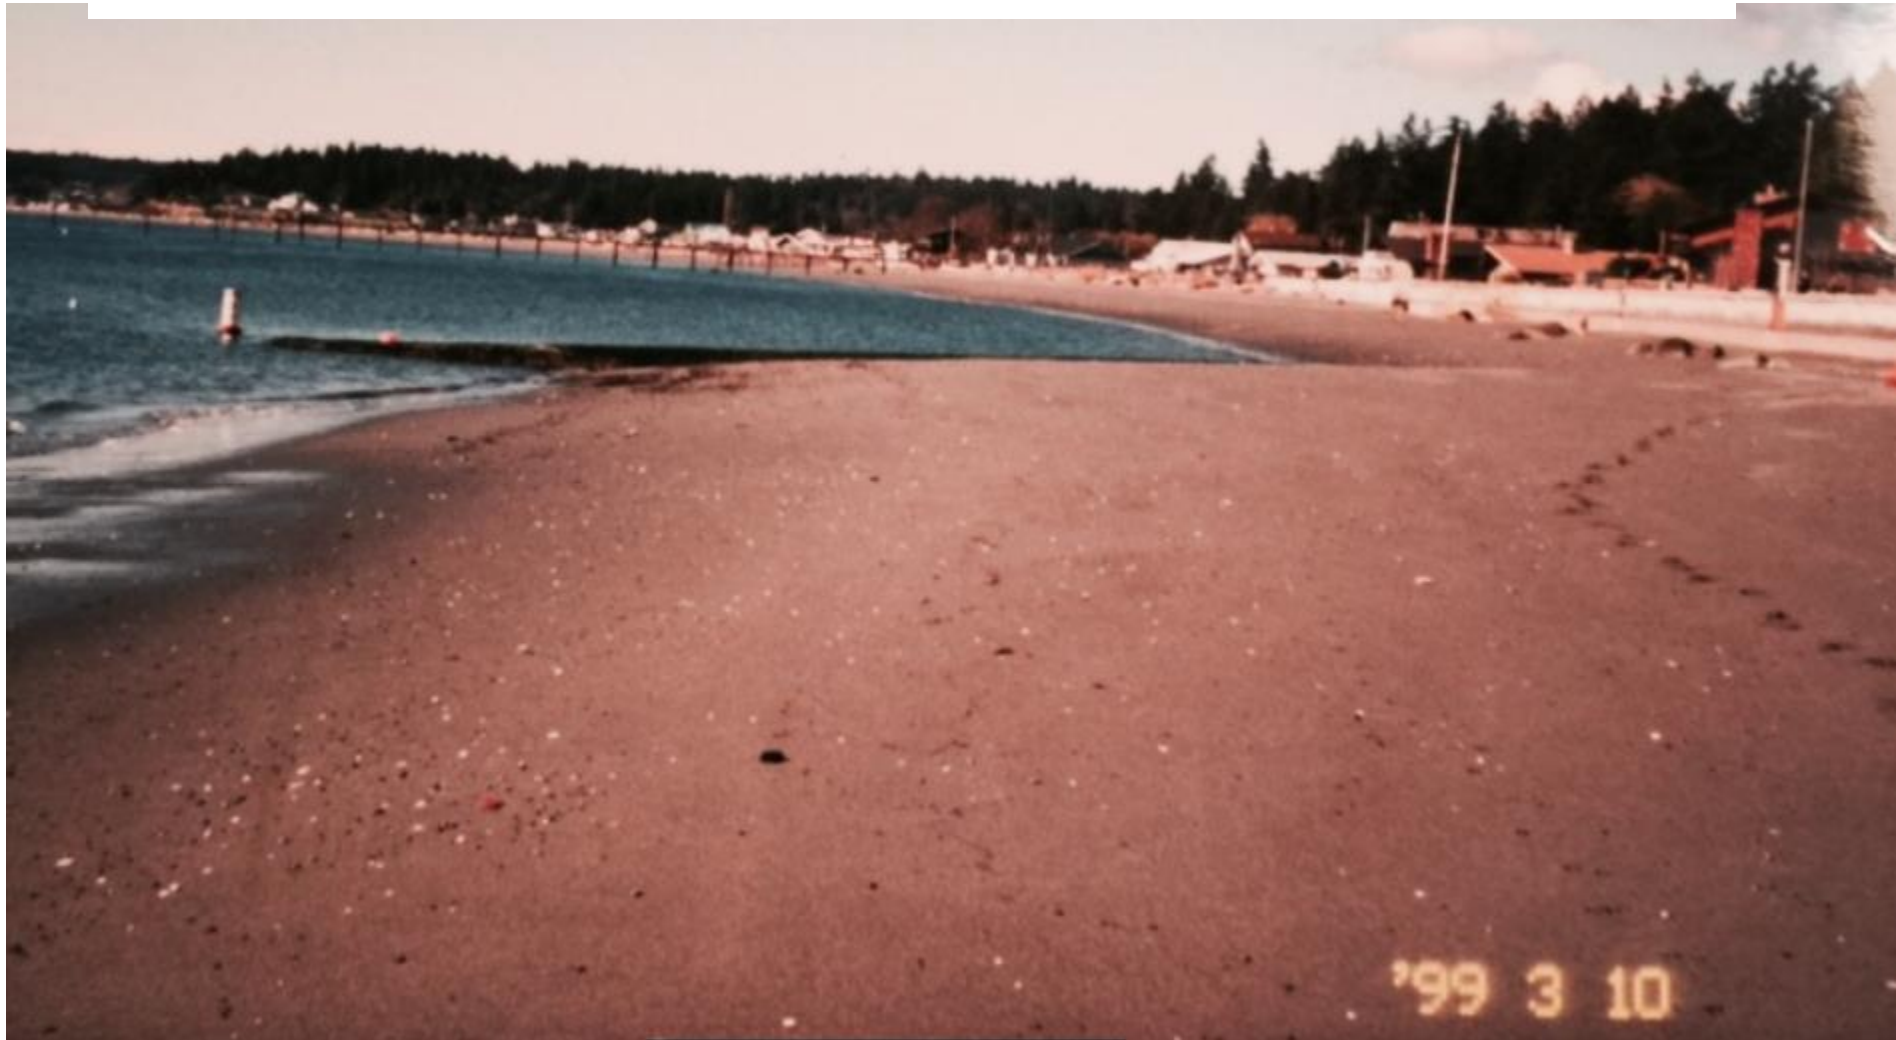
Mutiny Bay 1999 – Cedar Street Drain Pipe

In 1999 Island county tried to solve the Cedar street drainage problem by installing a big drainage pipe on the beach. the following Historical photo show the result. A sand bar was created up-drift of the pipe similar to the current sand bar

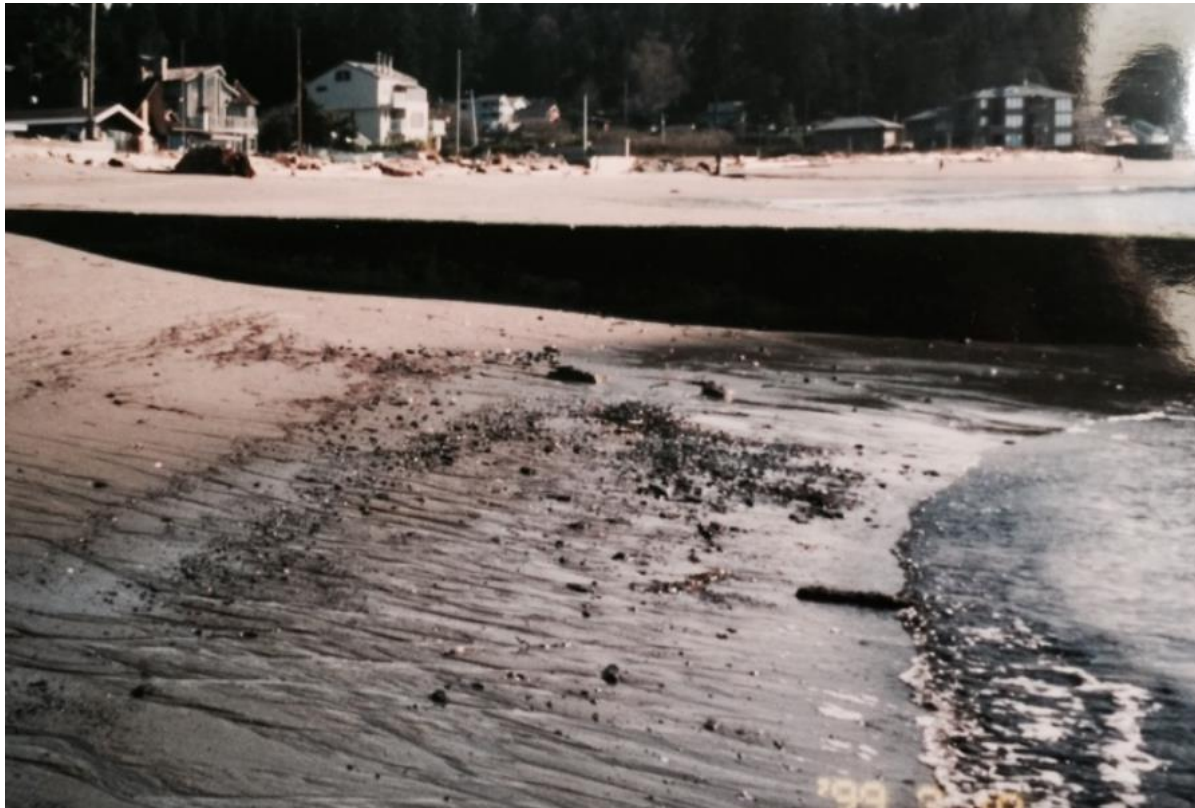
Mutiny Bay 1999

Down-Drift side of the big pipe shows the erosion on the down drift side of the pipe

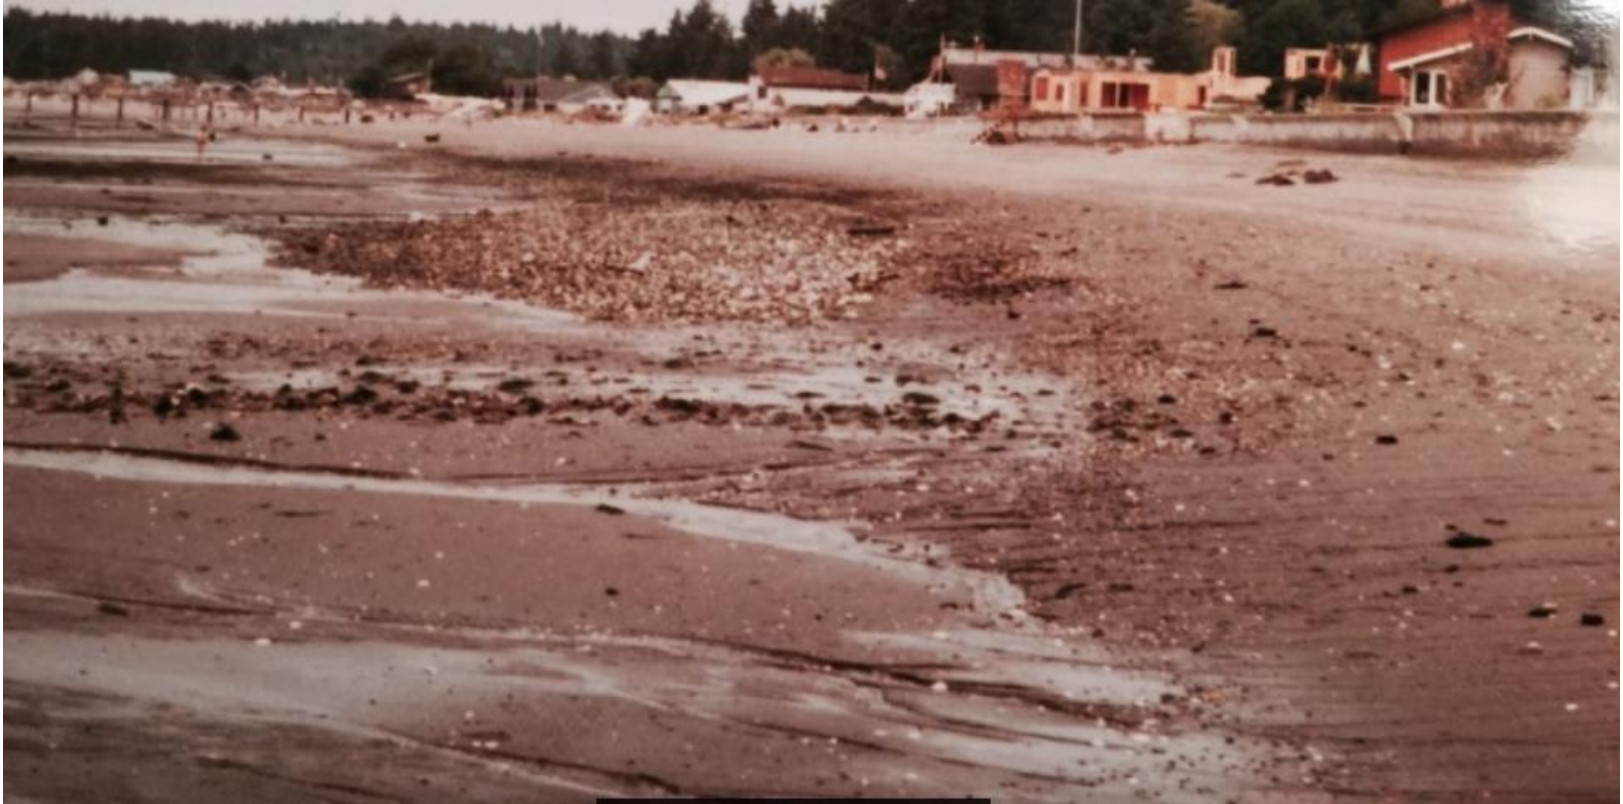
Mutiny Bay 1999 – Cedar Street Drain Pipe

You can see the erosion caused by the sand bar created by the drainage pipe. Island County is creating the same erosion scenario with the boat ramp dredging process.

It took Legal action against Island county to remove the pipe.

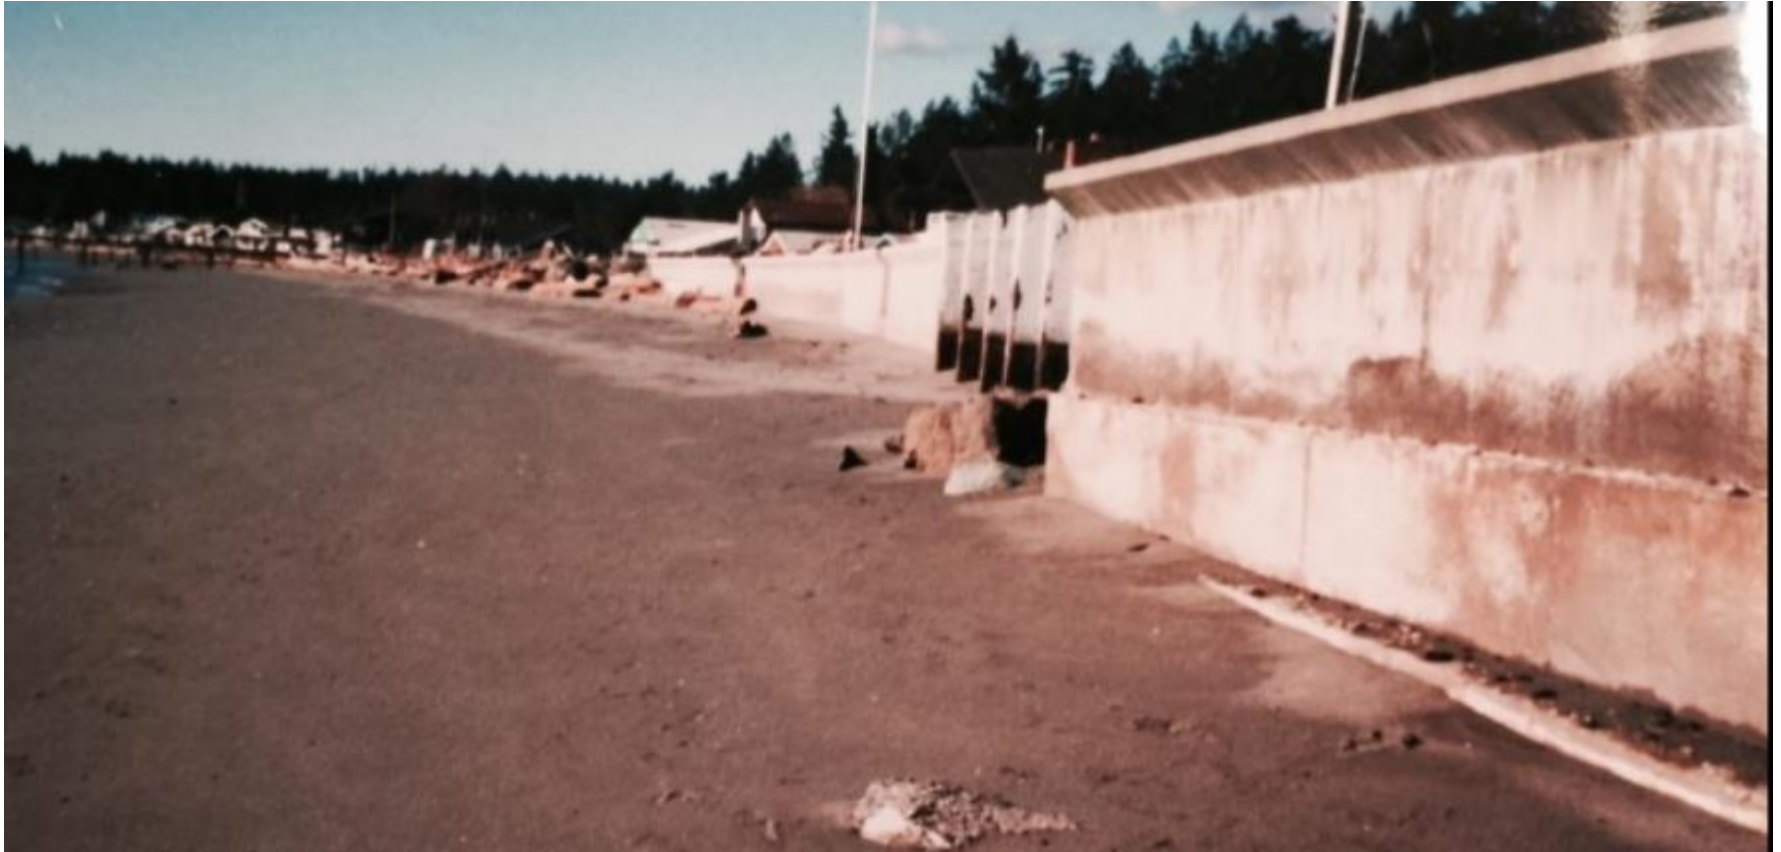
Mutiny Bay 1999 – Cedar Street Drain Pipe

This photo illustrates How much Sand was eroded down drift of the of the big pipe

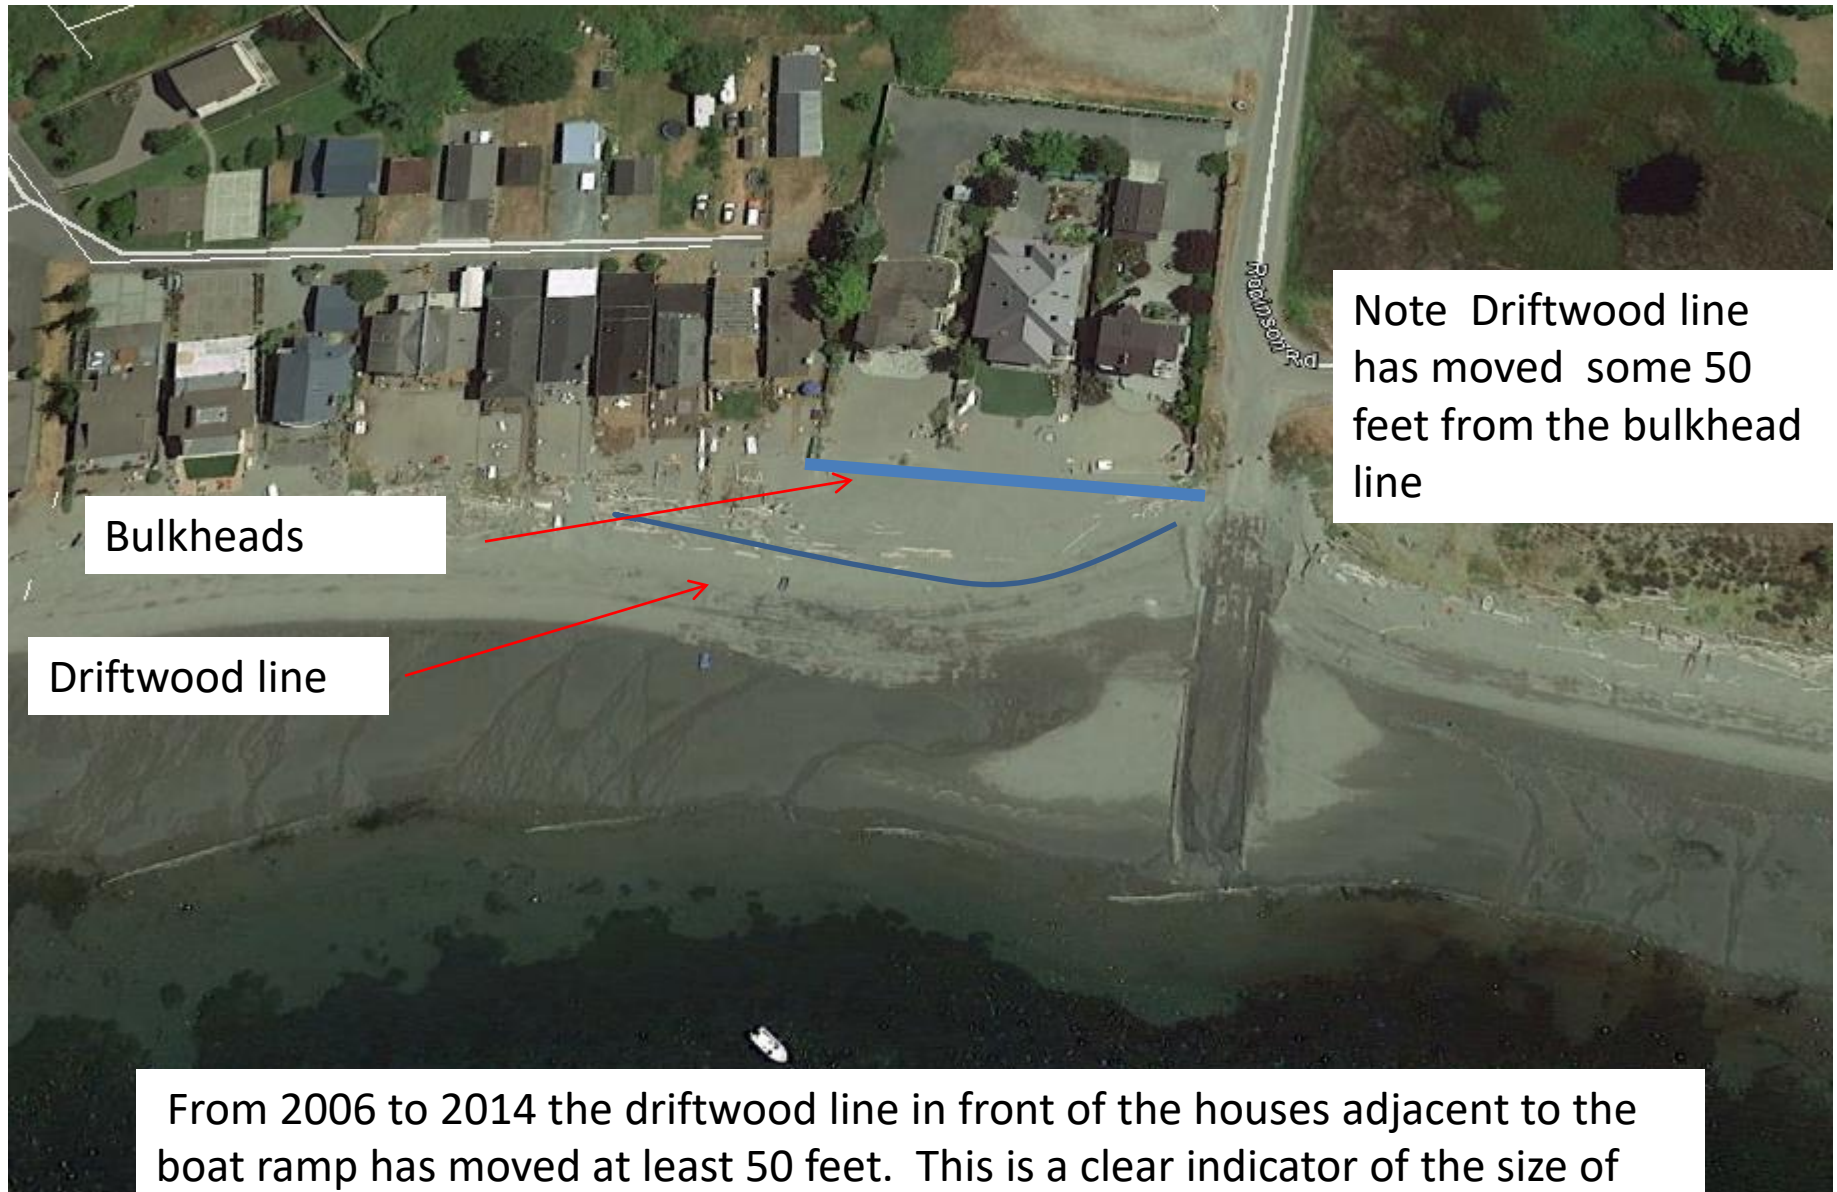
Driftwood line 2014

Note Driftwood line has moved some 50 feet from the bulkhead line

From 2006 to 2014 the driftwood line in front of the houses adjacent to the boat ramp has moved at least 50 feet. This is a clear indicator of the size of the sand bar created by the Island County boat ramp dredging operation.
