Mutiny Bay Boat Ramp Historical Observations

The objective of this presentation is to show how Mutiny bay has change over the last 20 years and illustrate how the counties dredging operations to maintain the boat ramp is adversely effecting the bays ecosystem.

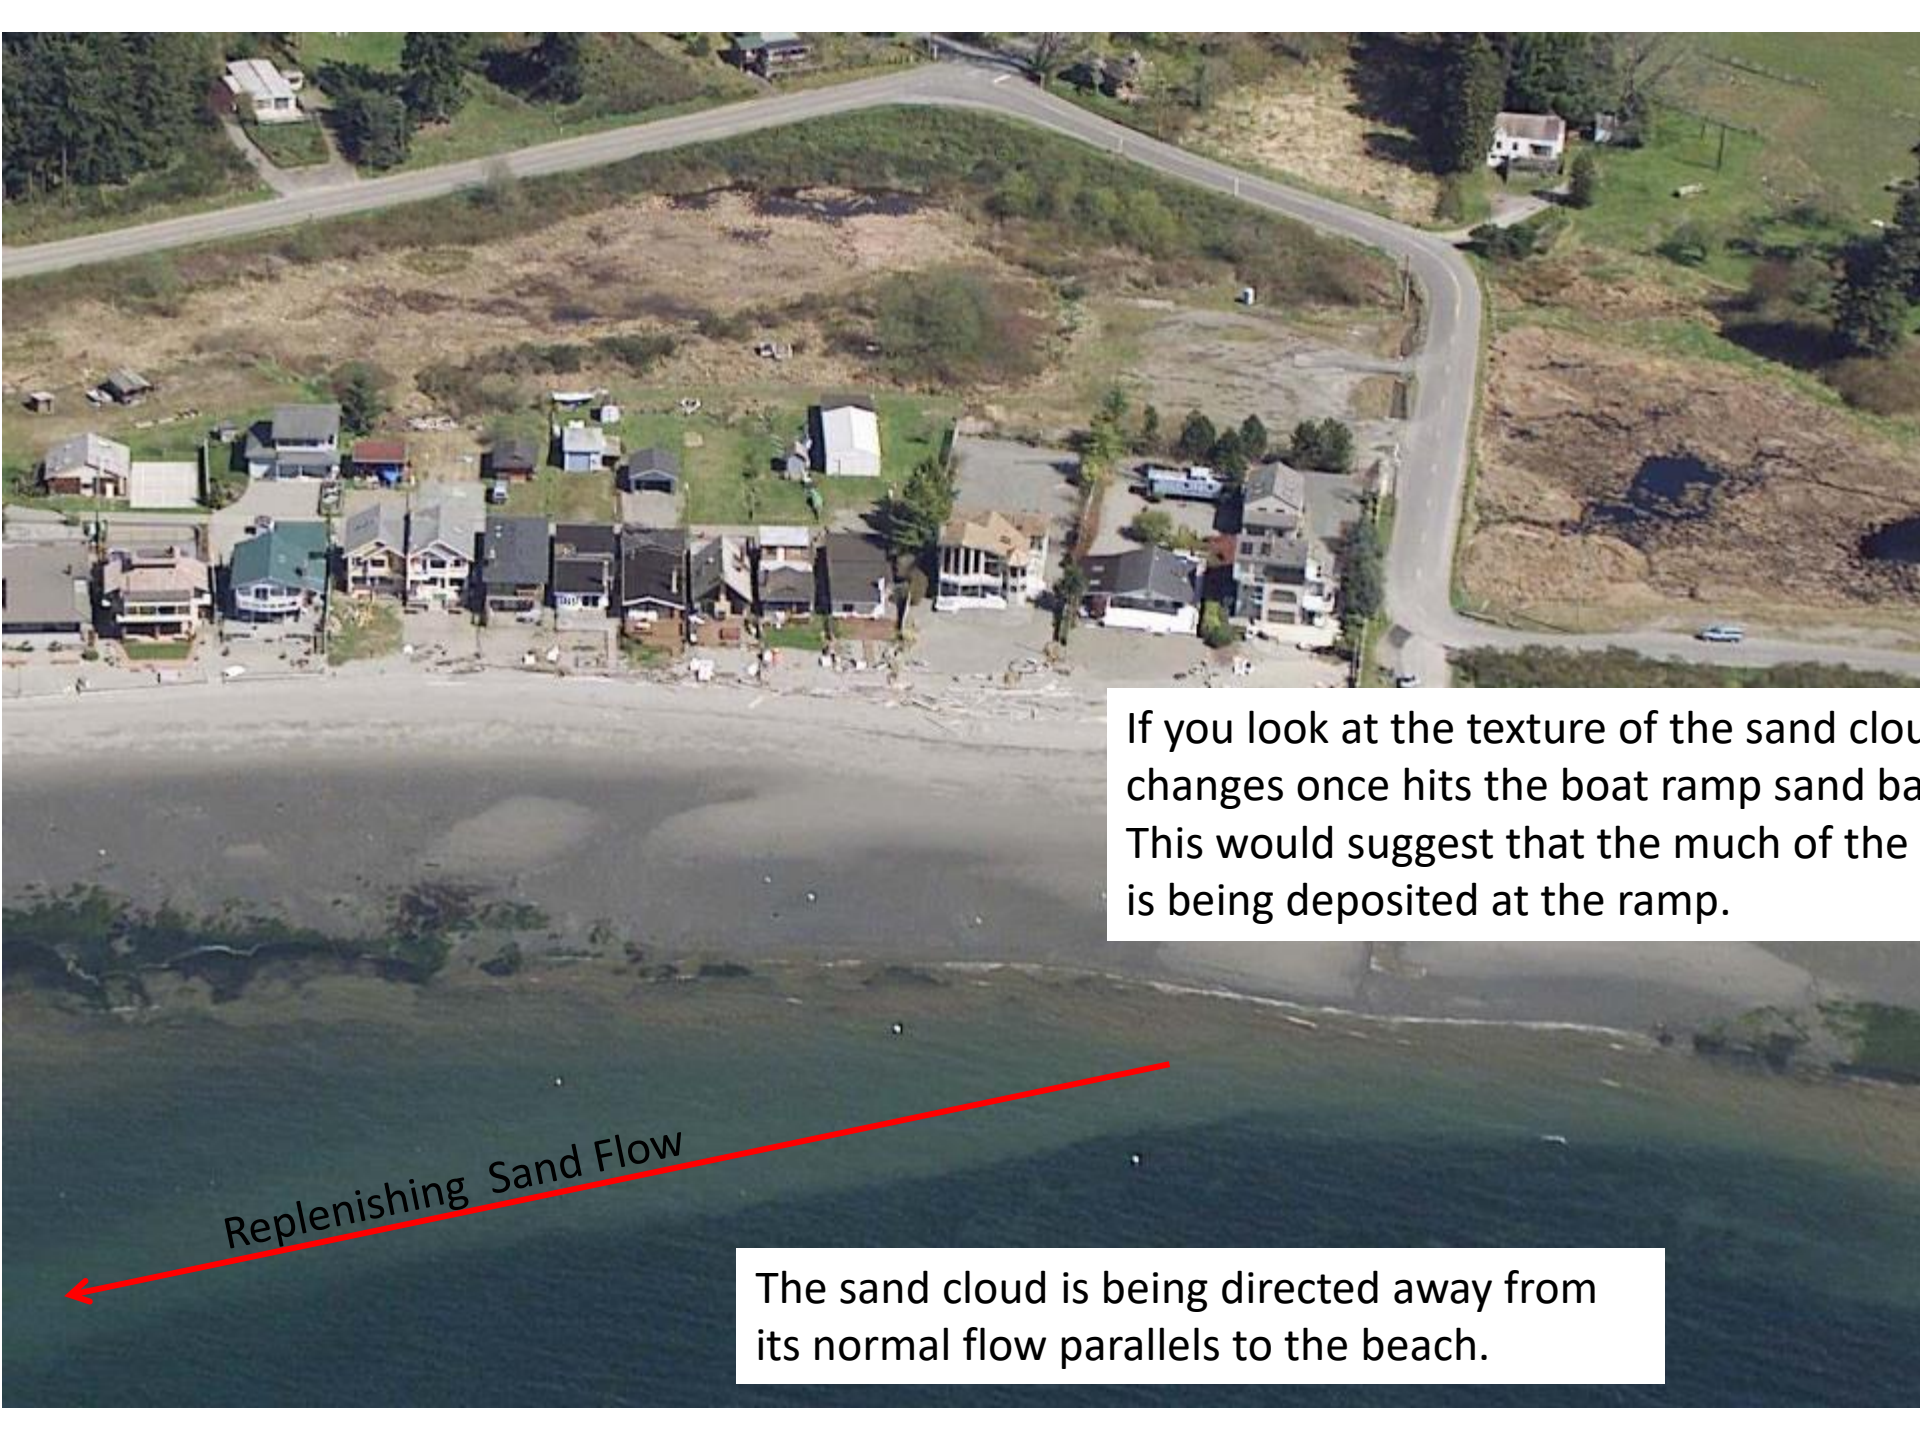
Sand flow moving along the beach driven by wind and tide

If you look at the texture of the sand cloud, it changes once it hits the boat ramp sand bar. This would suggest that much of the sand is being deposited at the ramp.

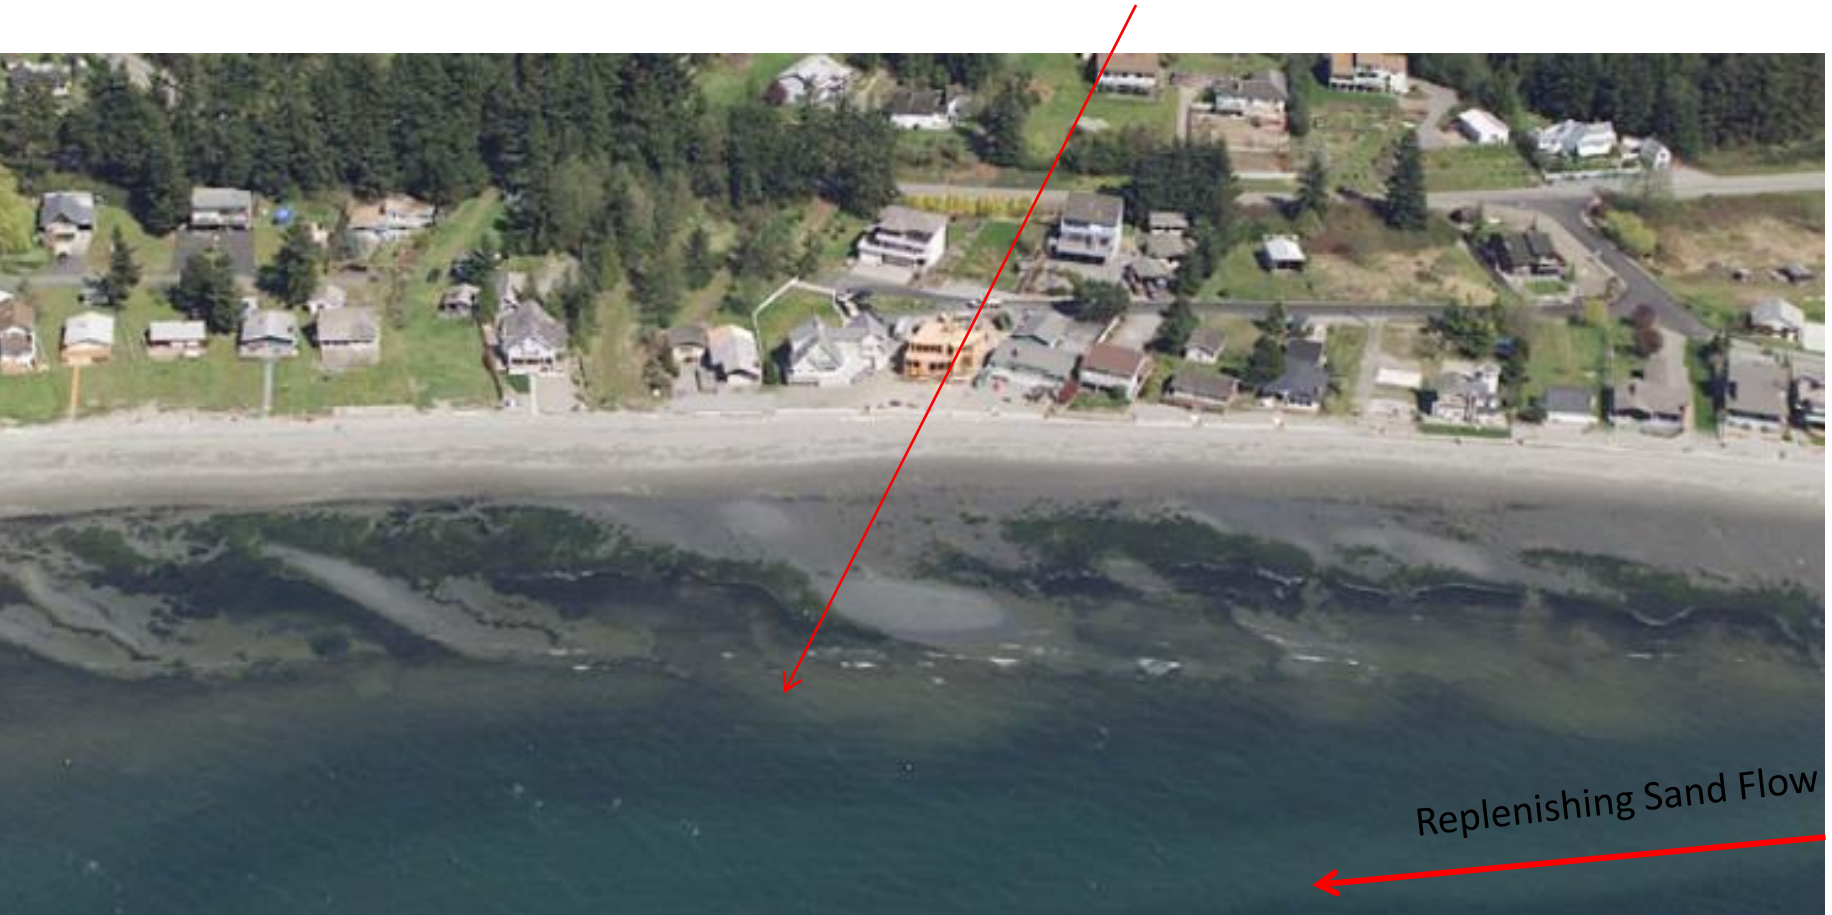
Replenishing Sand Flow

The existing sand along the beach is picked up and moved north, the replenishing sand misses those properties north of the boat ramp. This is why the beach is eroding.

The picture clearly shows the replenishing sand being diverted in 2001 when the sand bar was small compared to what it now !

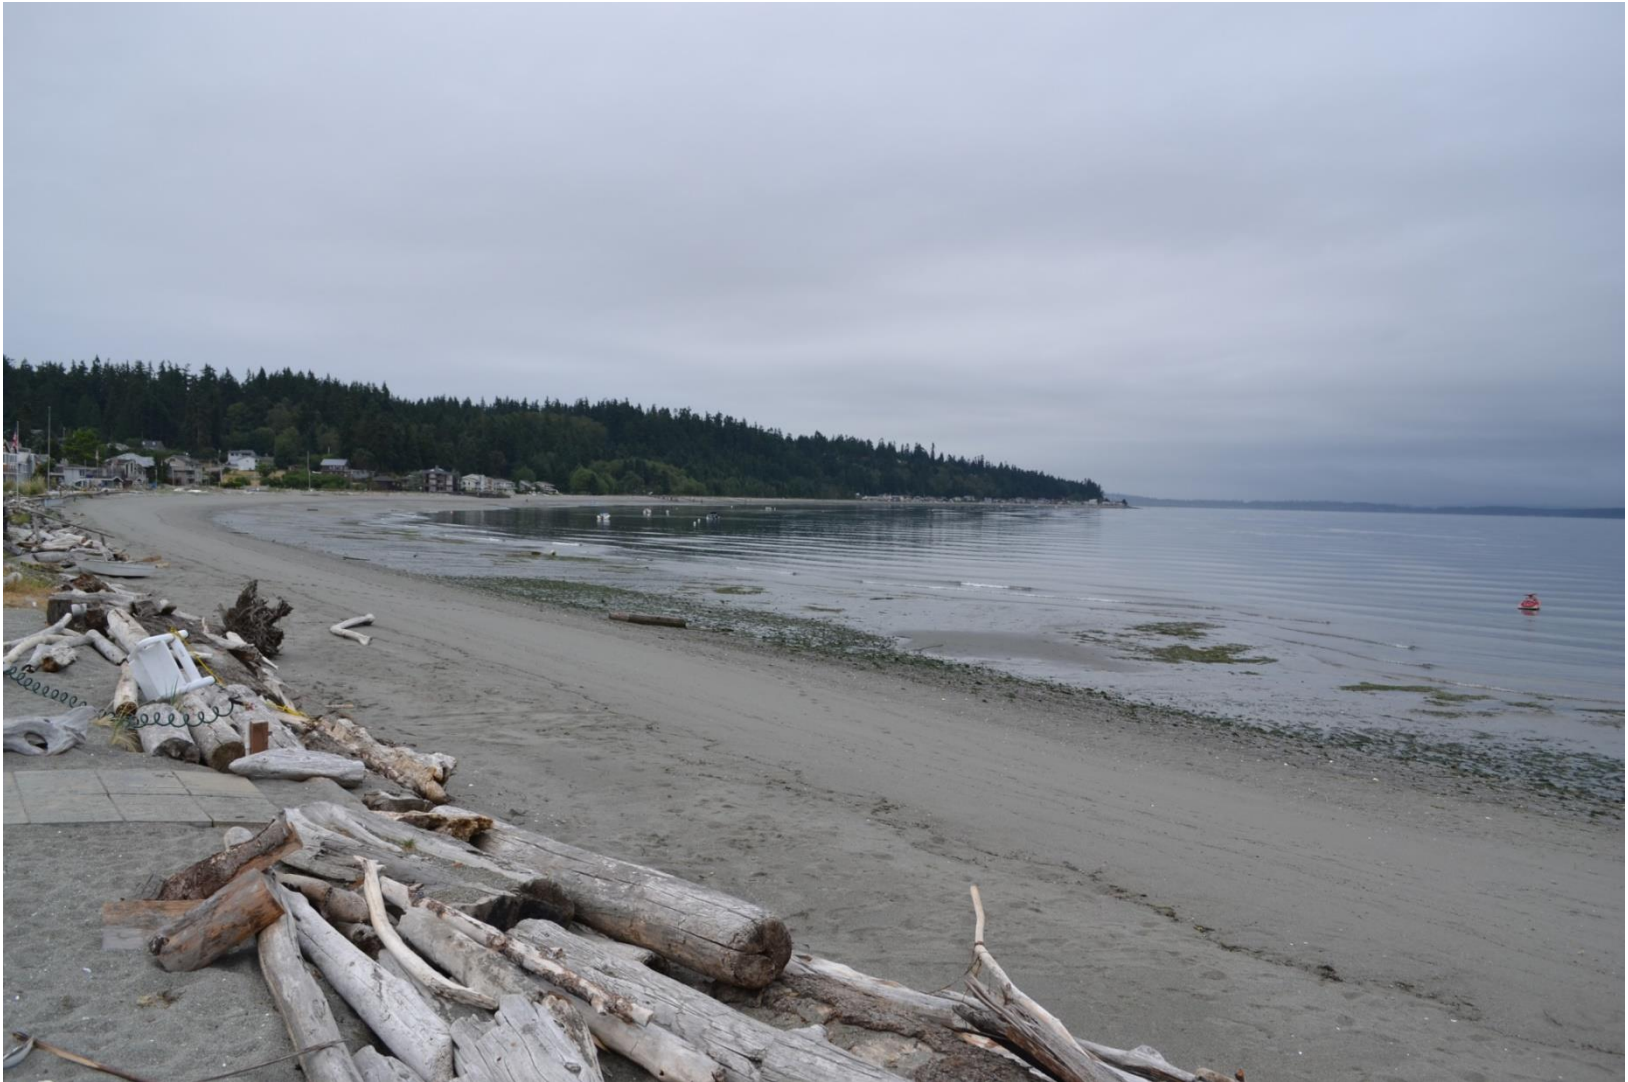
now

for those that have lived along Mutiny bay for 50 years can remember there were only a few rocks before the tide flats. That has changed, the quantity of exposed rocks are many – giving credence to the presented replenishing sand flows are being stopped and being redirected by the boat ramp sand bar.

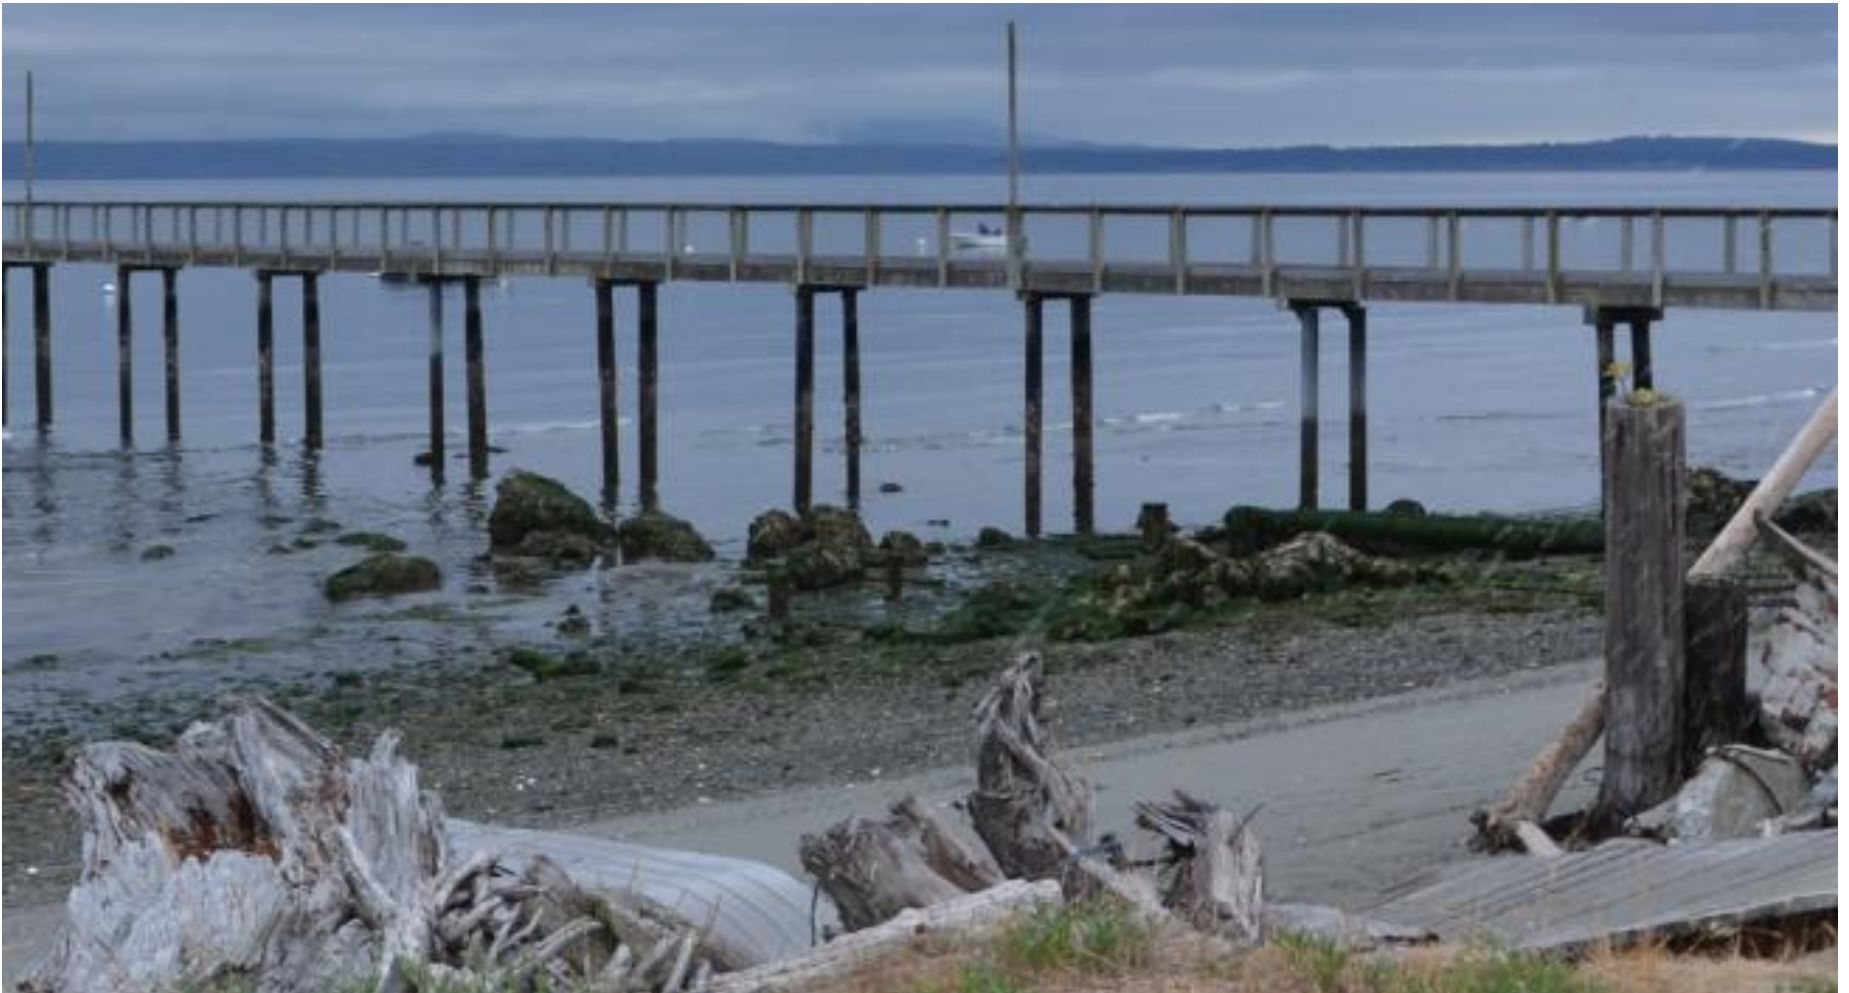
Now

This shows show the extent of the erosion

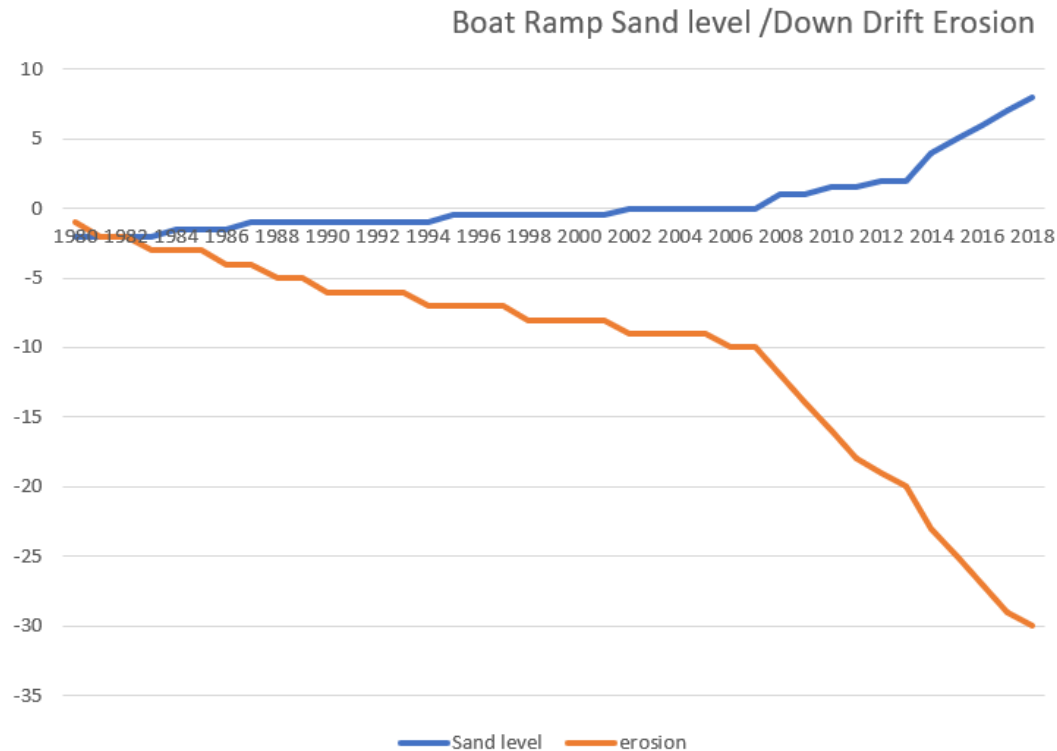
Erosion Graph

The following graph shows the relationship between sand levels over the boat ramp surface based on photographic estimates and down drift erosion

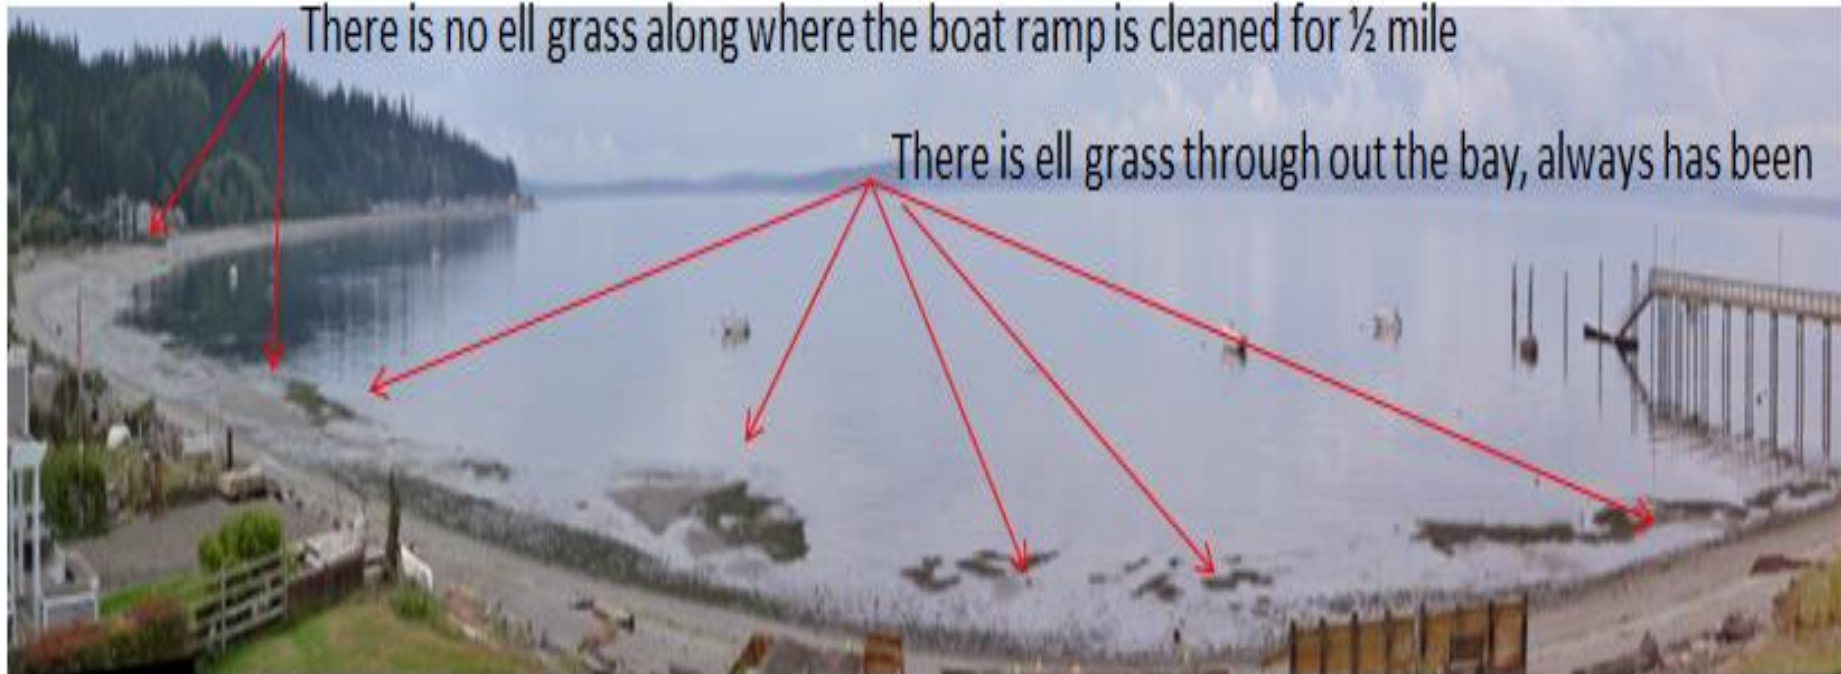
There is no ell grass along where the boat ramp is cleaned for ½ mile

There is ell grass through out the bay, always has been

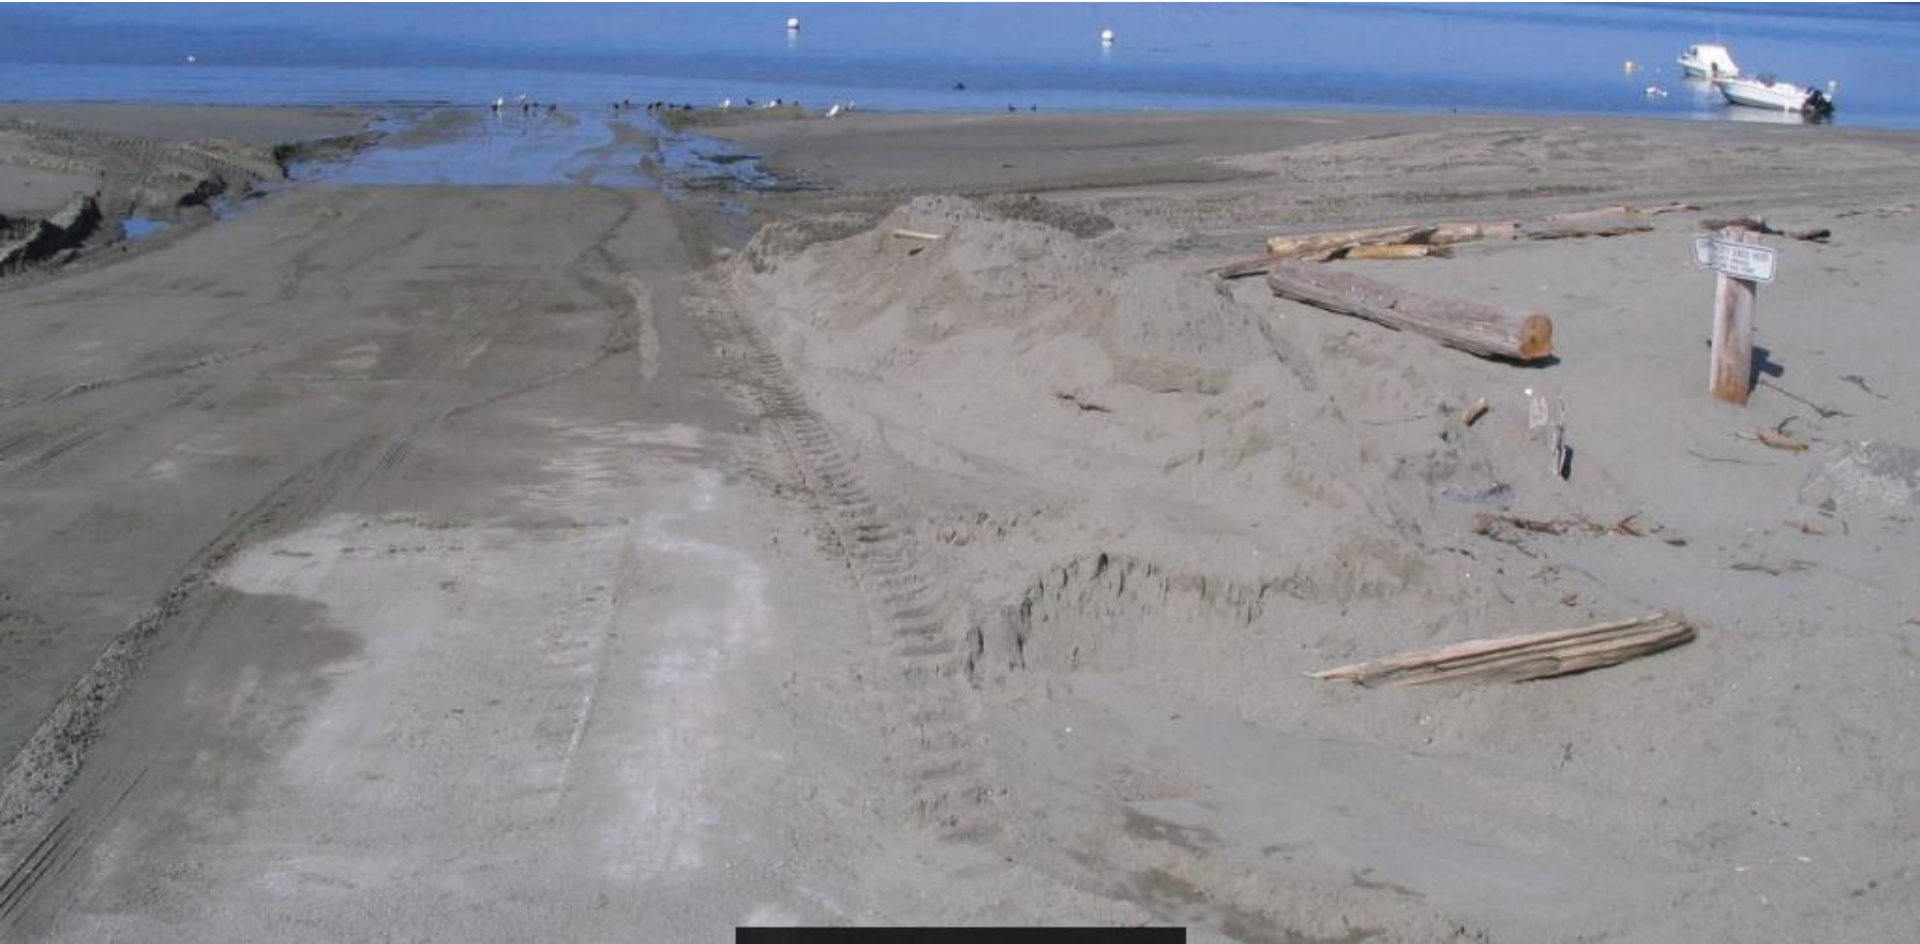
Boat ramp cleaning 2007

In 2007 the Mutiny Bay boat Ramp Cleaning operation was more of a cleaning operation

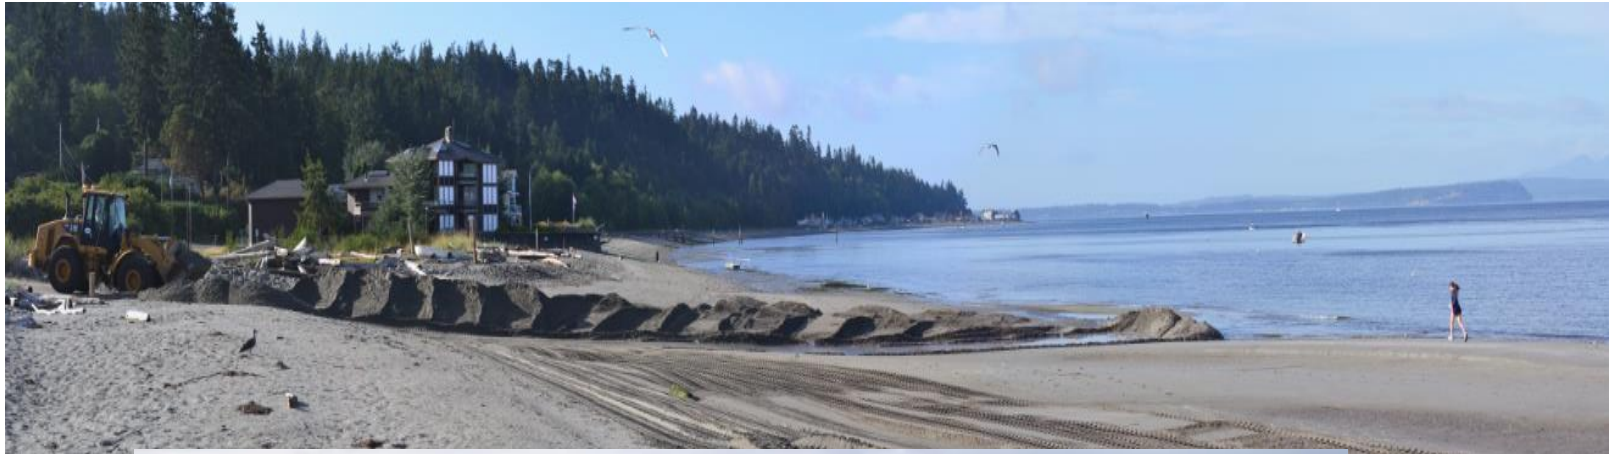
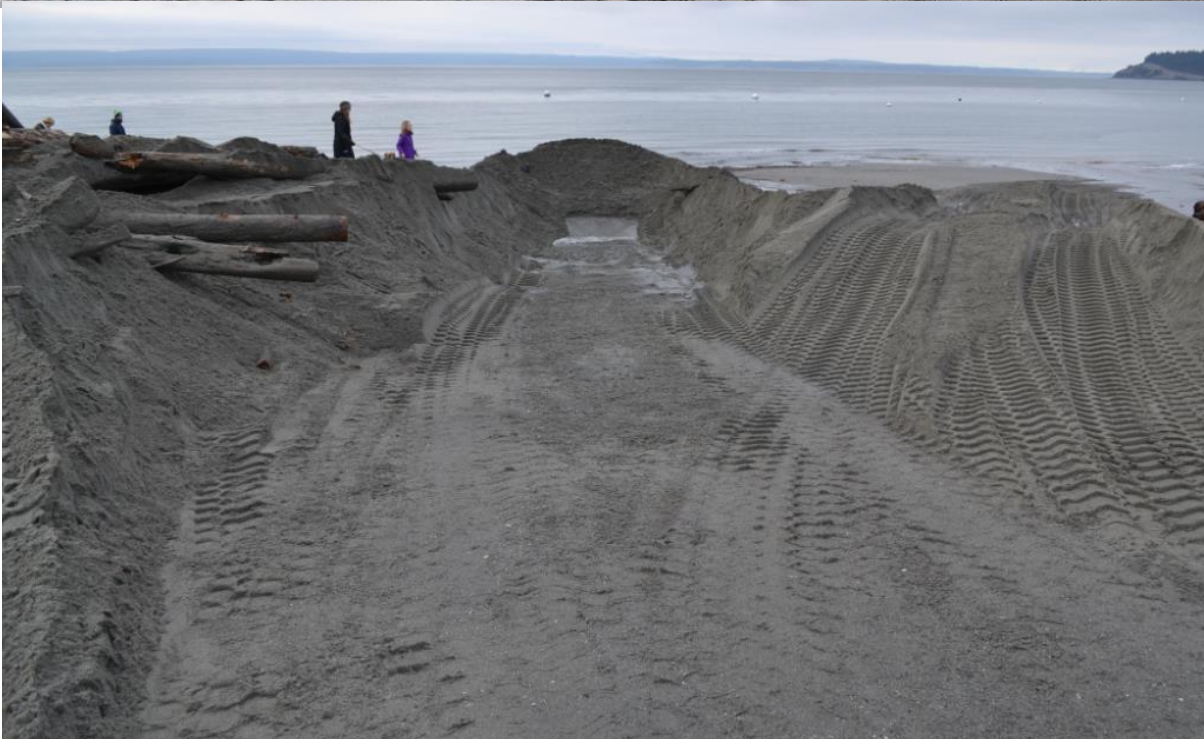
Boat ramp dredging summer 2015

In 2015 the process evolved into a full fledged dredging operation

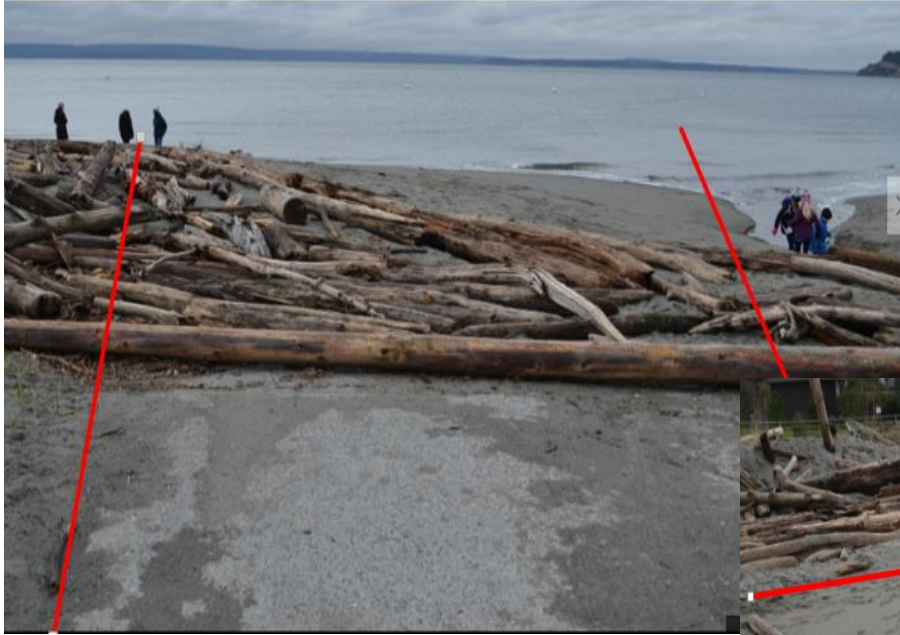
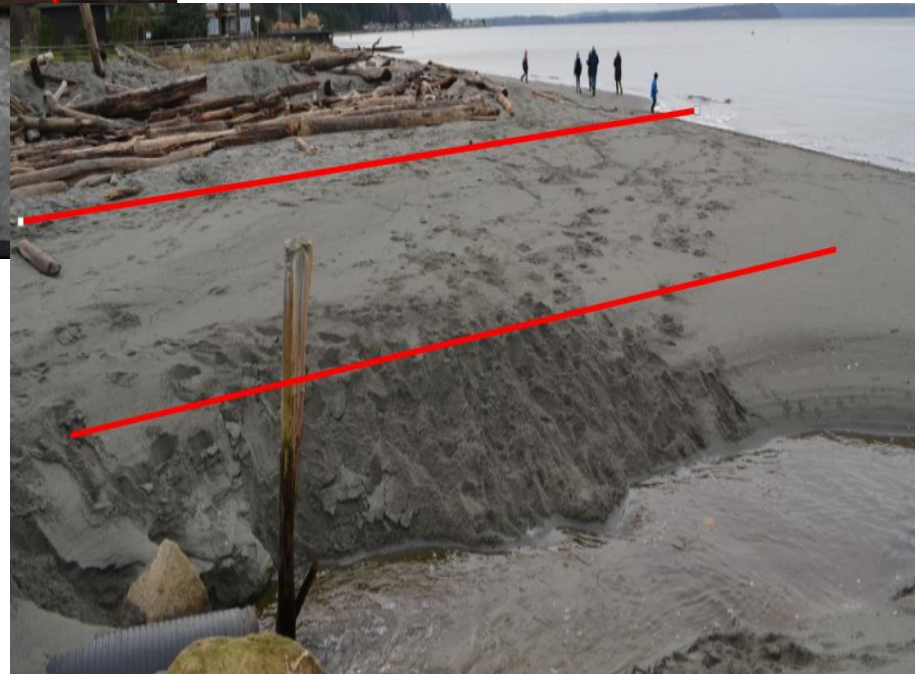
Boat ramp dredging Winter 2015

These photos show the boat ramp just before the dredging operation. The depth of the sand over the boat ramp is 7 to 8 feet.

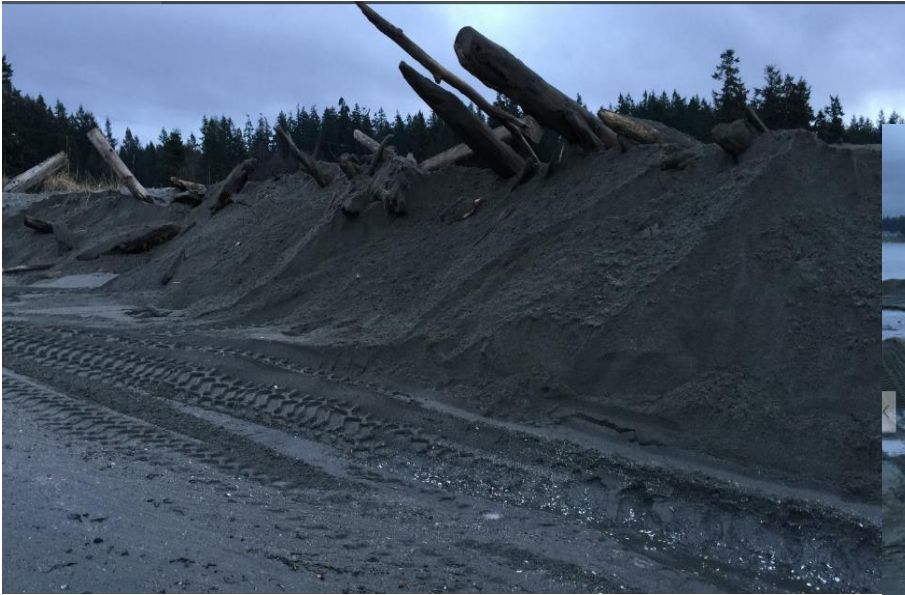
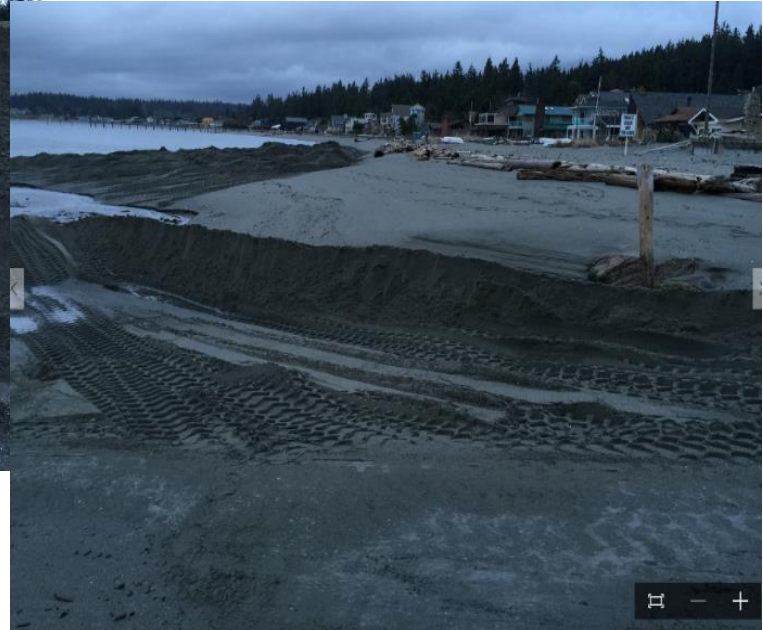
Winter 2015

These photos show the results of the dredging operation and where the sediment was deposited on private tidelands with no written permission from the land owners

The estimated volume of sand “Cleaned” from the boat ramp is $(100 \text{ feet} * 20 \text{ feet} * 7) / 27 = 518$ Cubic yards. In a year this adds up to around 3000 cubic yards dredged and moved.

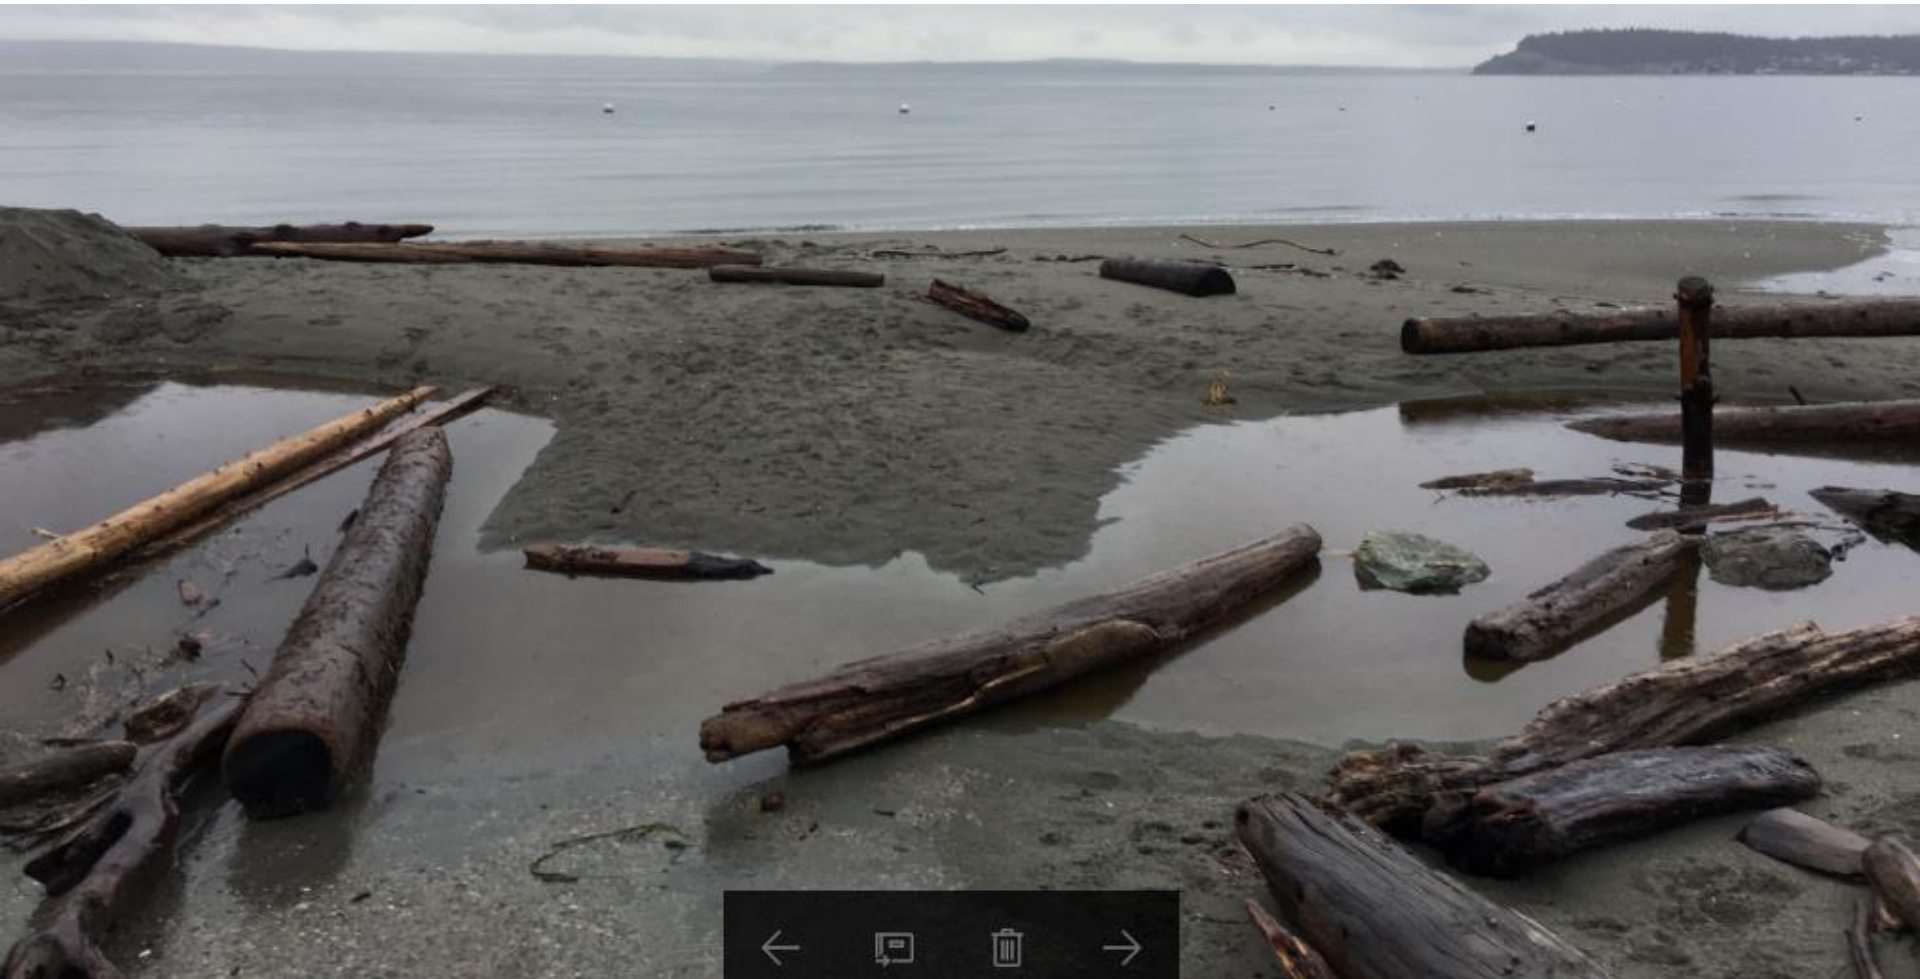
Winter 2016

The Ramp was not dredged as of Christmas 2016. The sand depth over the ramp is estimated to be 9 to 10 feet. Note: the drain line is almost plugged. A heavy rain storm would result it local flooding

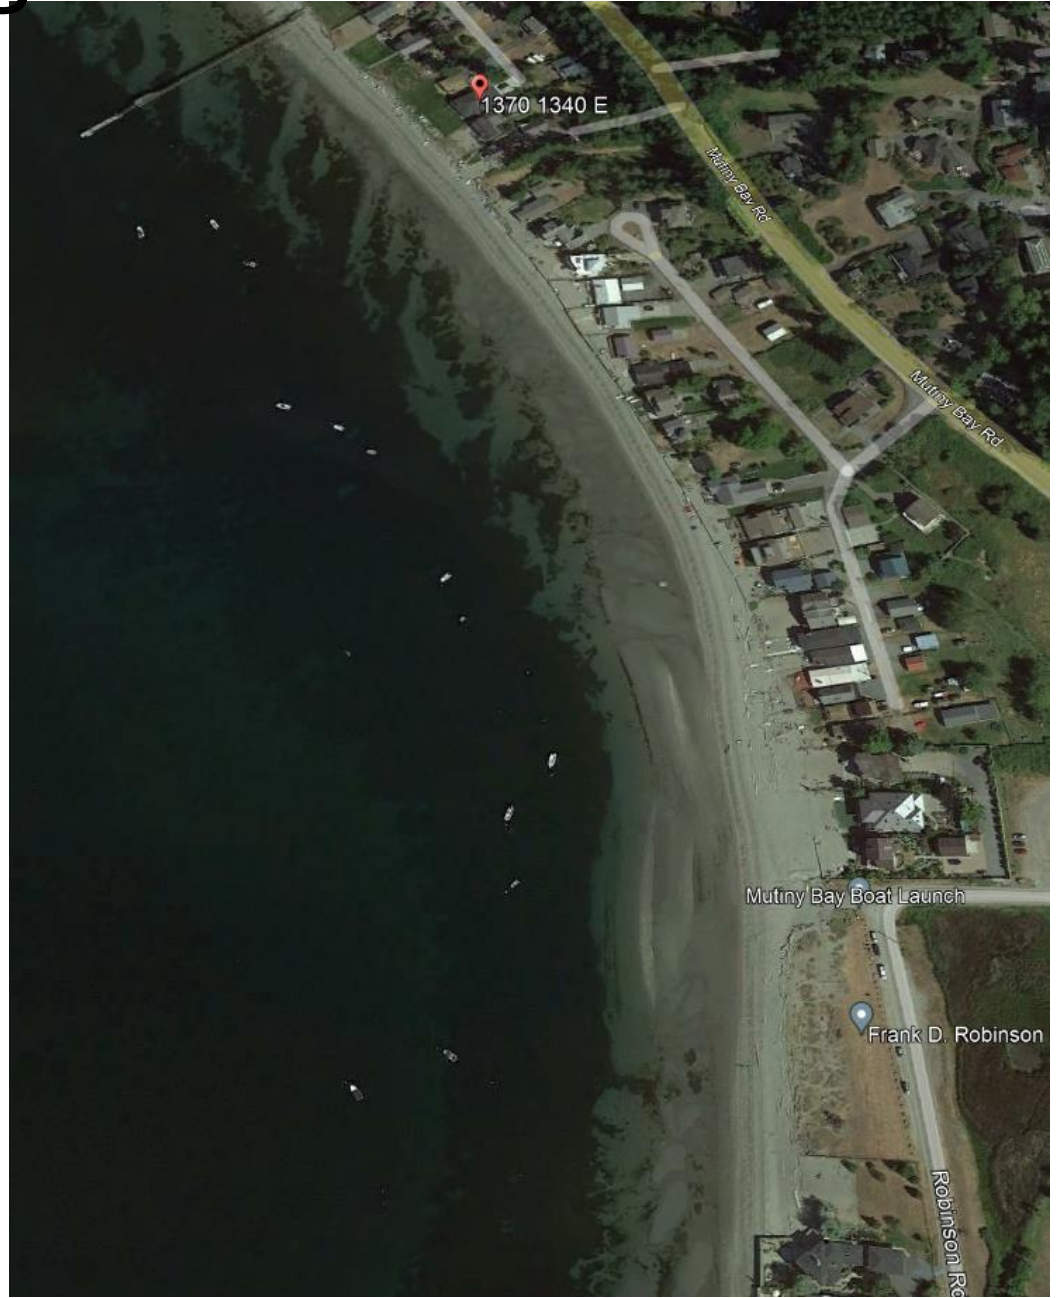
Google Earth 2020

This is the Google Earth photo taken on the summer of 2020. This photo illustrates that nature is slowly returning the shape of the bay to its historical crescent curvature.
