Mutiny Bay Boat Ramp Historical Observations

The objective of this presentation is to show how Mutiny bay has change over the last 20 years and illustrate how the counties dredging operations to maintain the boat ramp is adversely effecting the bays ecosystem.

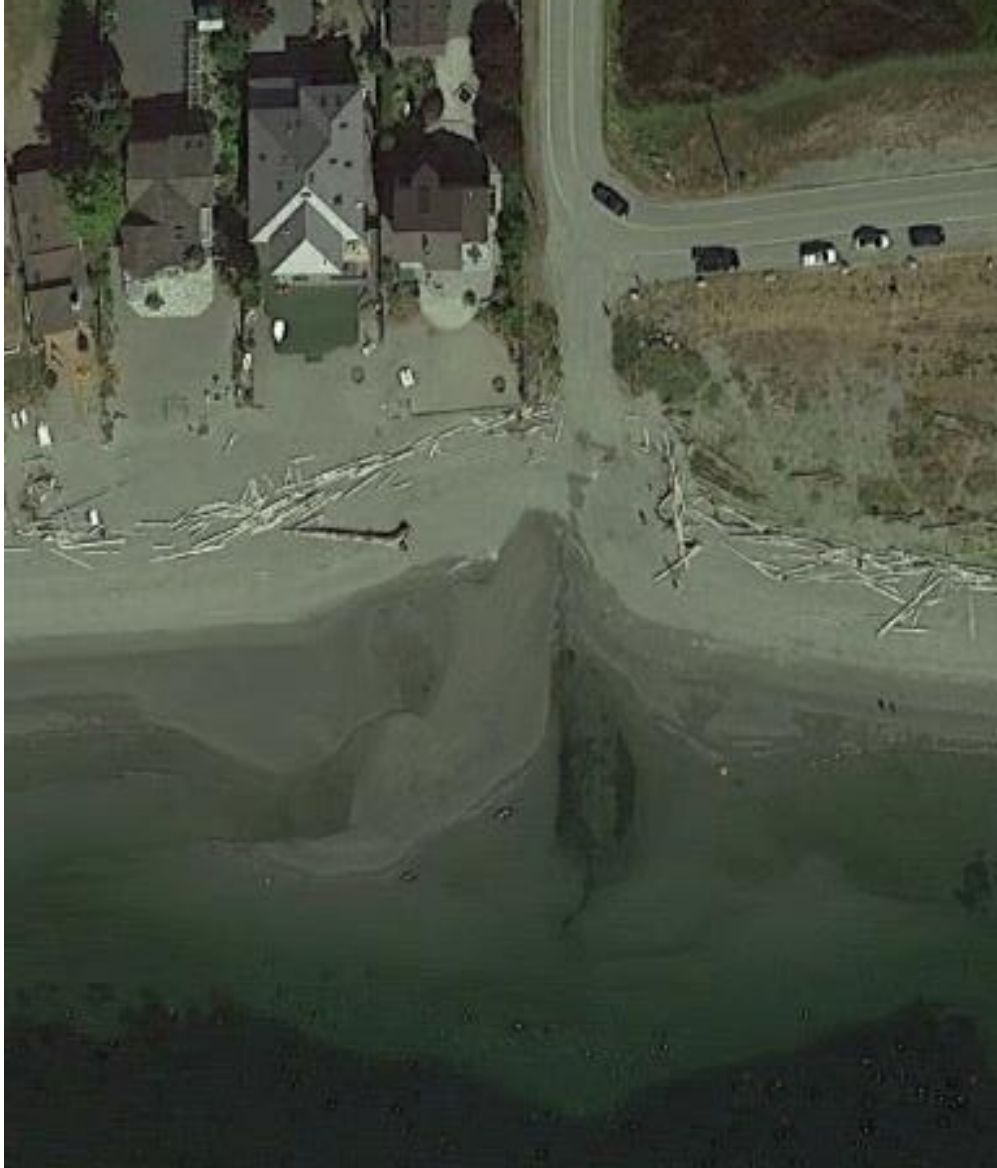
Mutiny Bay 2016 Google Earth

Note the sand bar is on both sides of boat ramp has grown from 2001

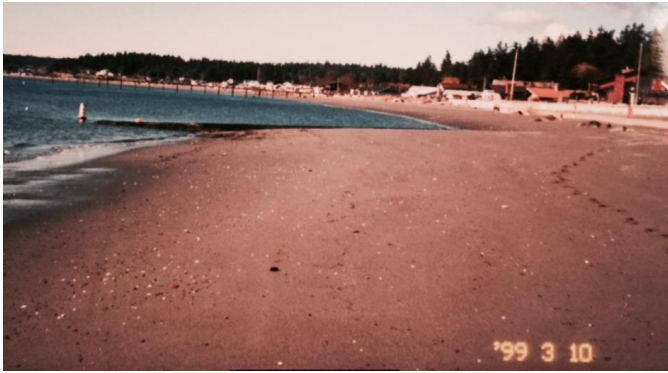
Mutiny Bay 1999 – how Does this compare to todays situation?

The previous historical photos showed the erosion caused by the drain pipe. the drainage pipe created a sand bar up-drift of the pipe, resulting in erosion down-drift properties

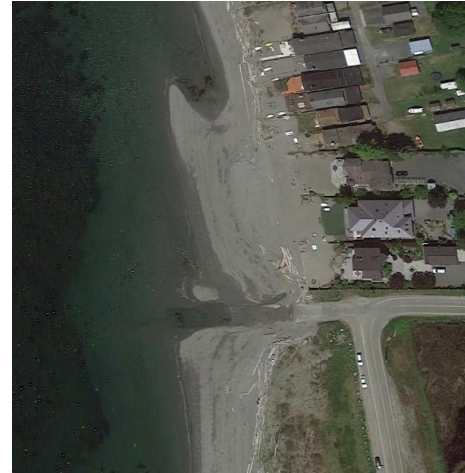
2017

The sand bar created by Island Counties dredging is creating the same situation, a bigger sandbar that results is the same erosion down-drift

The current Mutiny Bay boat ramp cleaning dredging operation Island is in violation of it's Shore Line Management Plan and will eventually result in the same type of erosion as the drain pipe.

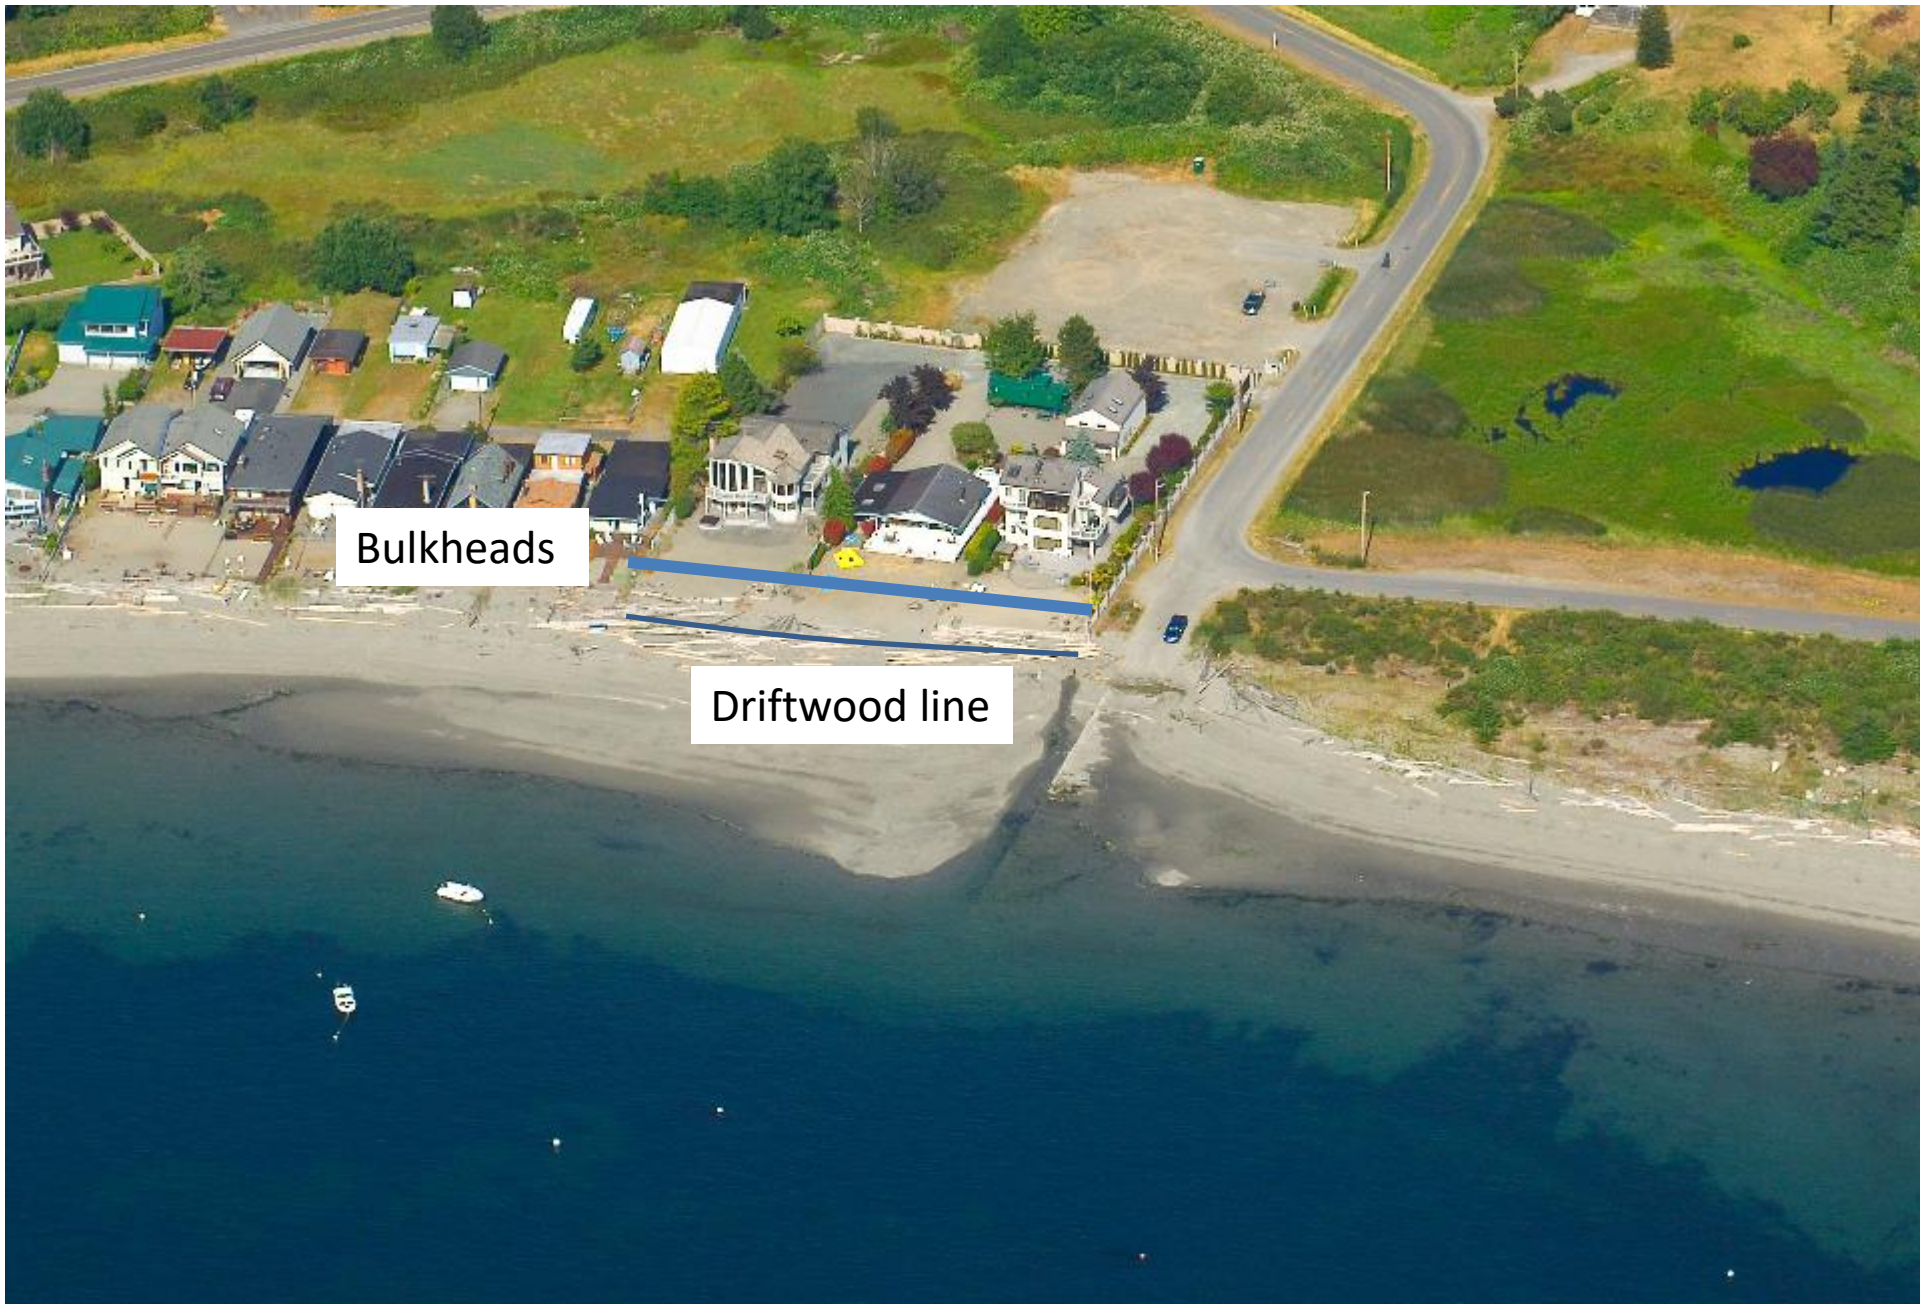
Driftwood line 2006

From 2006 to 2014 the driftwood line in front of the houses adjacent to the boat ramp has moved at least 50 feet. This is a clear indicator of the size of the sand bar created by the Island County boat ramp dredging operation.

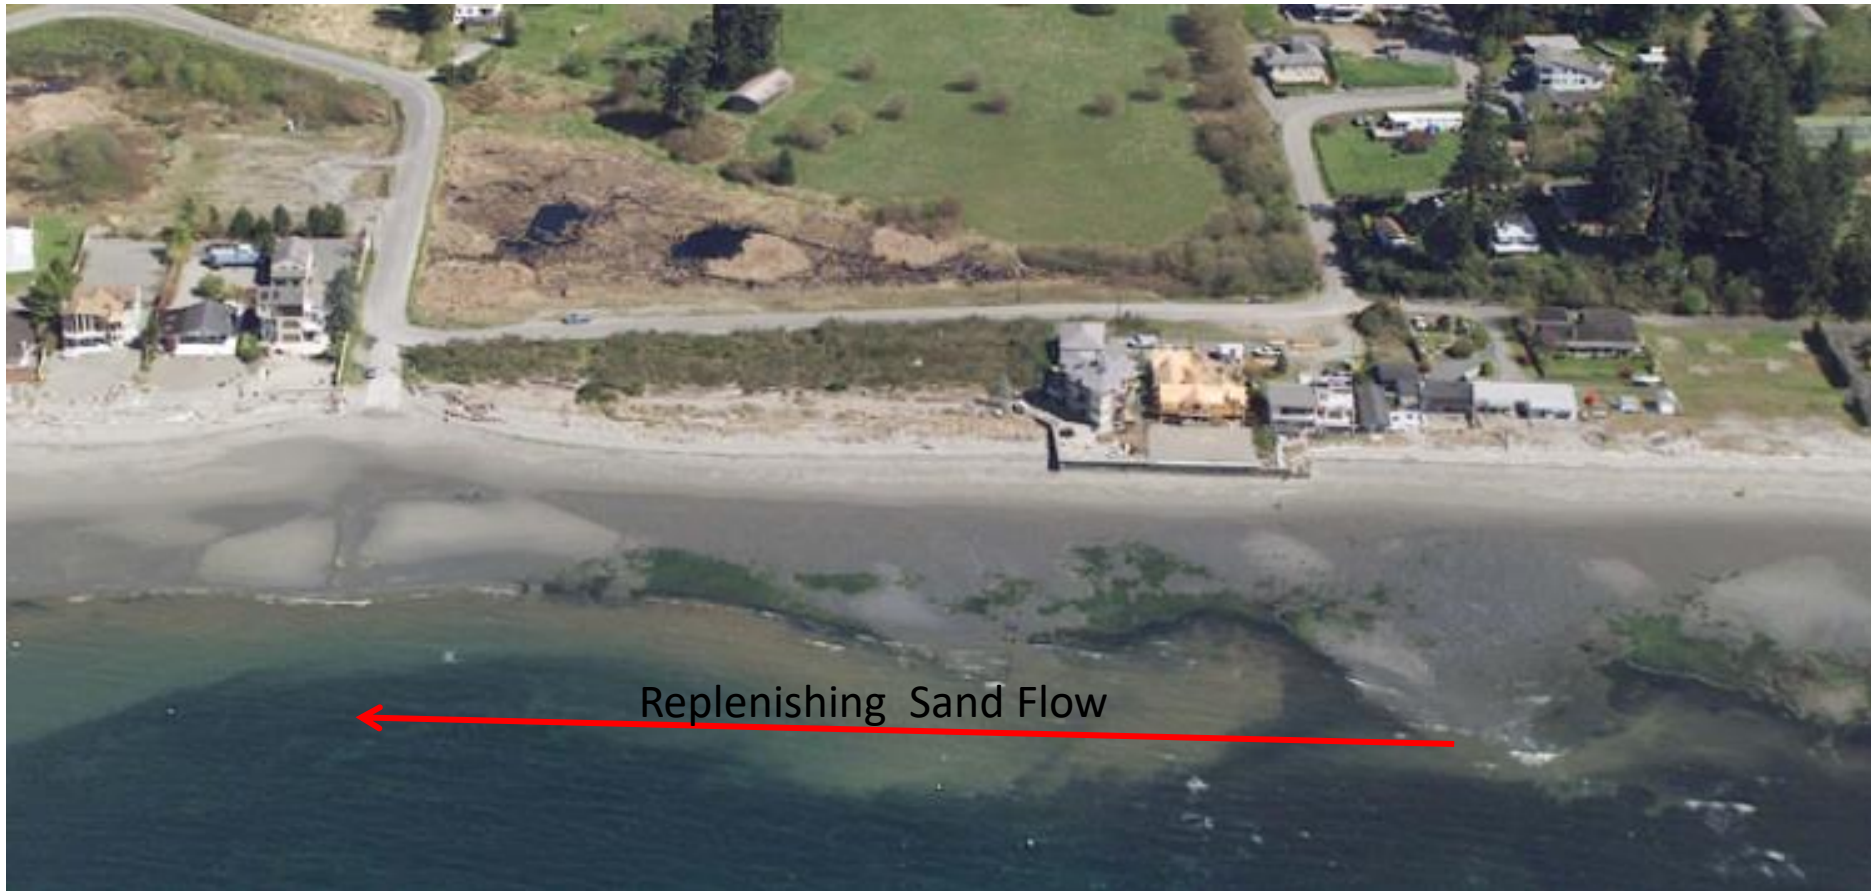
2001 Aerial photo

Sand flow moving along the beach driven by wind and tide

If you look at the texture of the sand cloud, it changes once it hits the boat ramp sand bar. This would suggest that much of the sand is being deposited at the ramp.

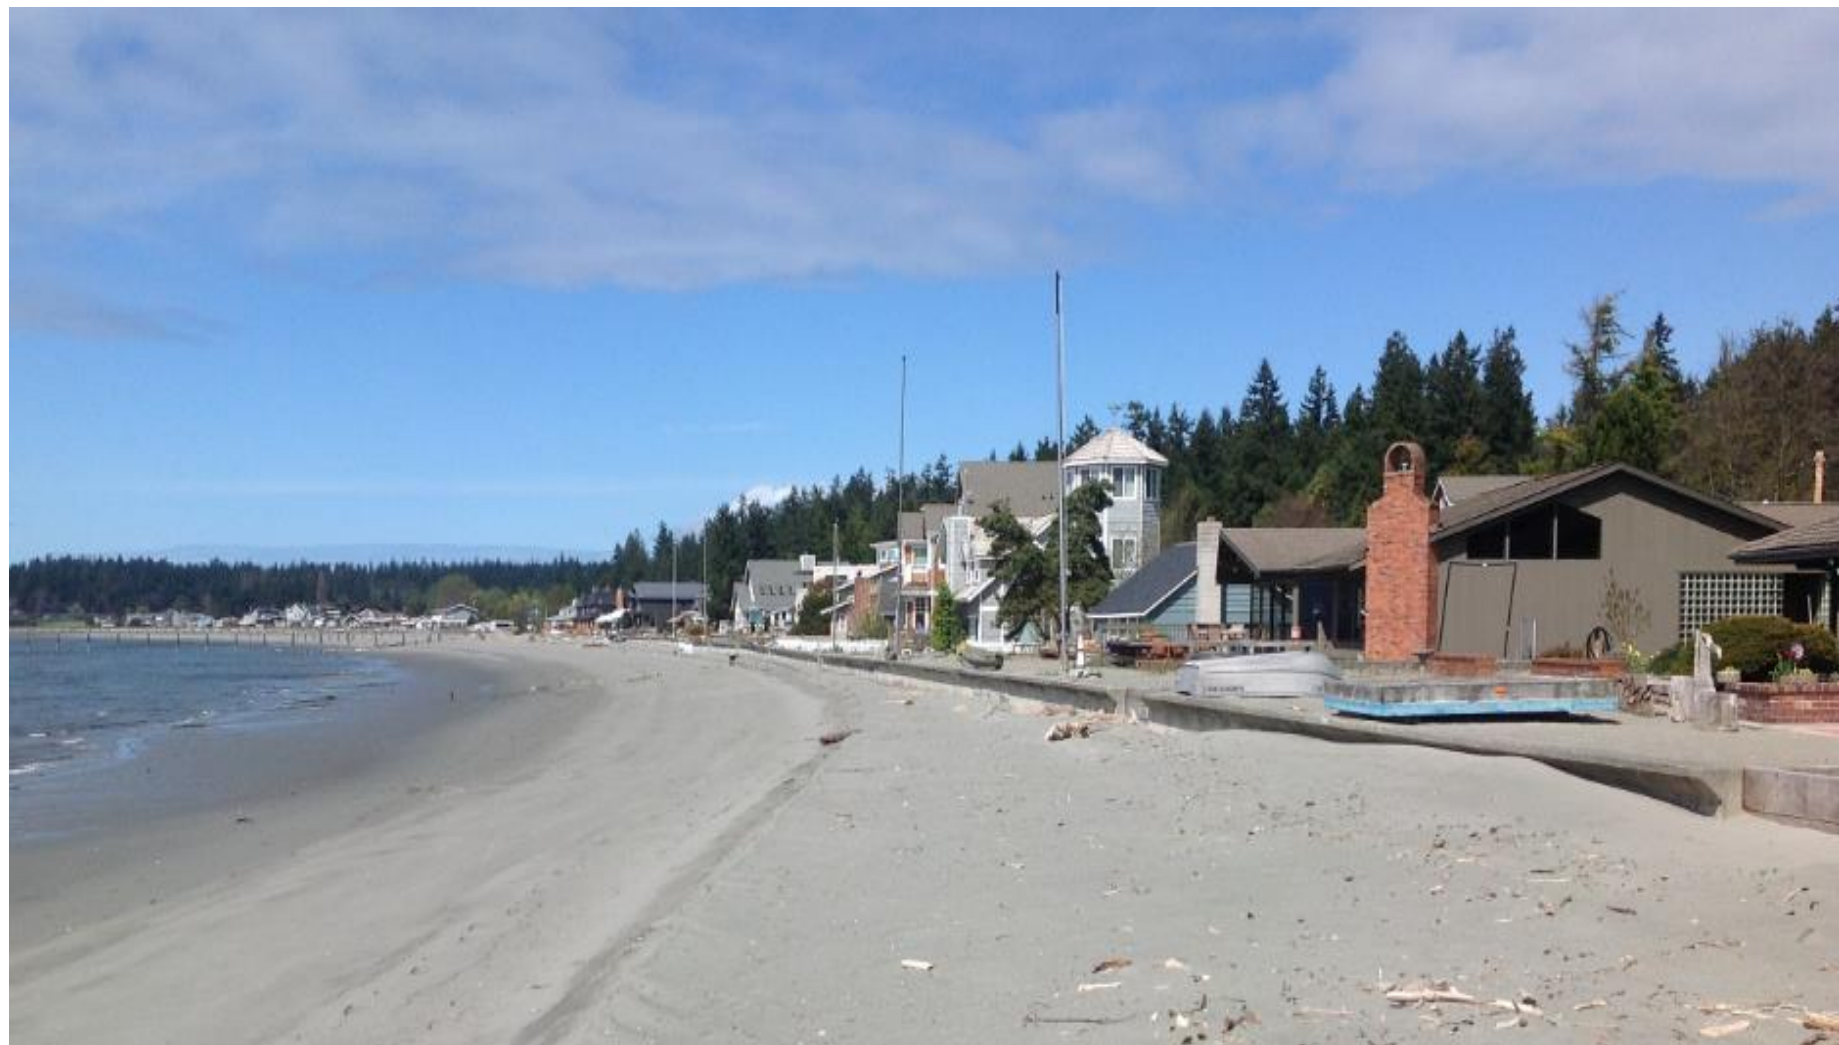
View of the beach 2013 – pristine sand beach you can see all the way to old Mutiny Bay resort nothing but sand

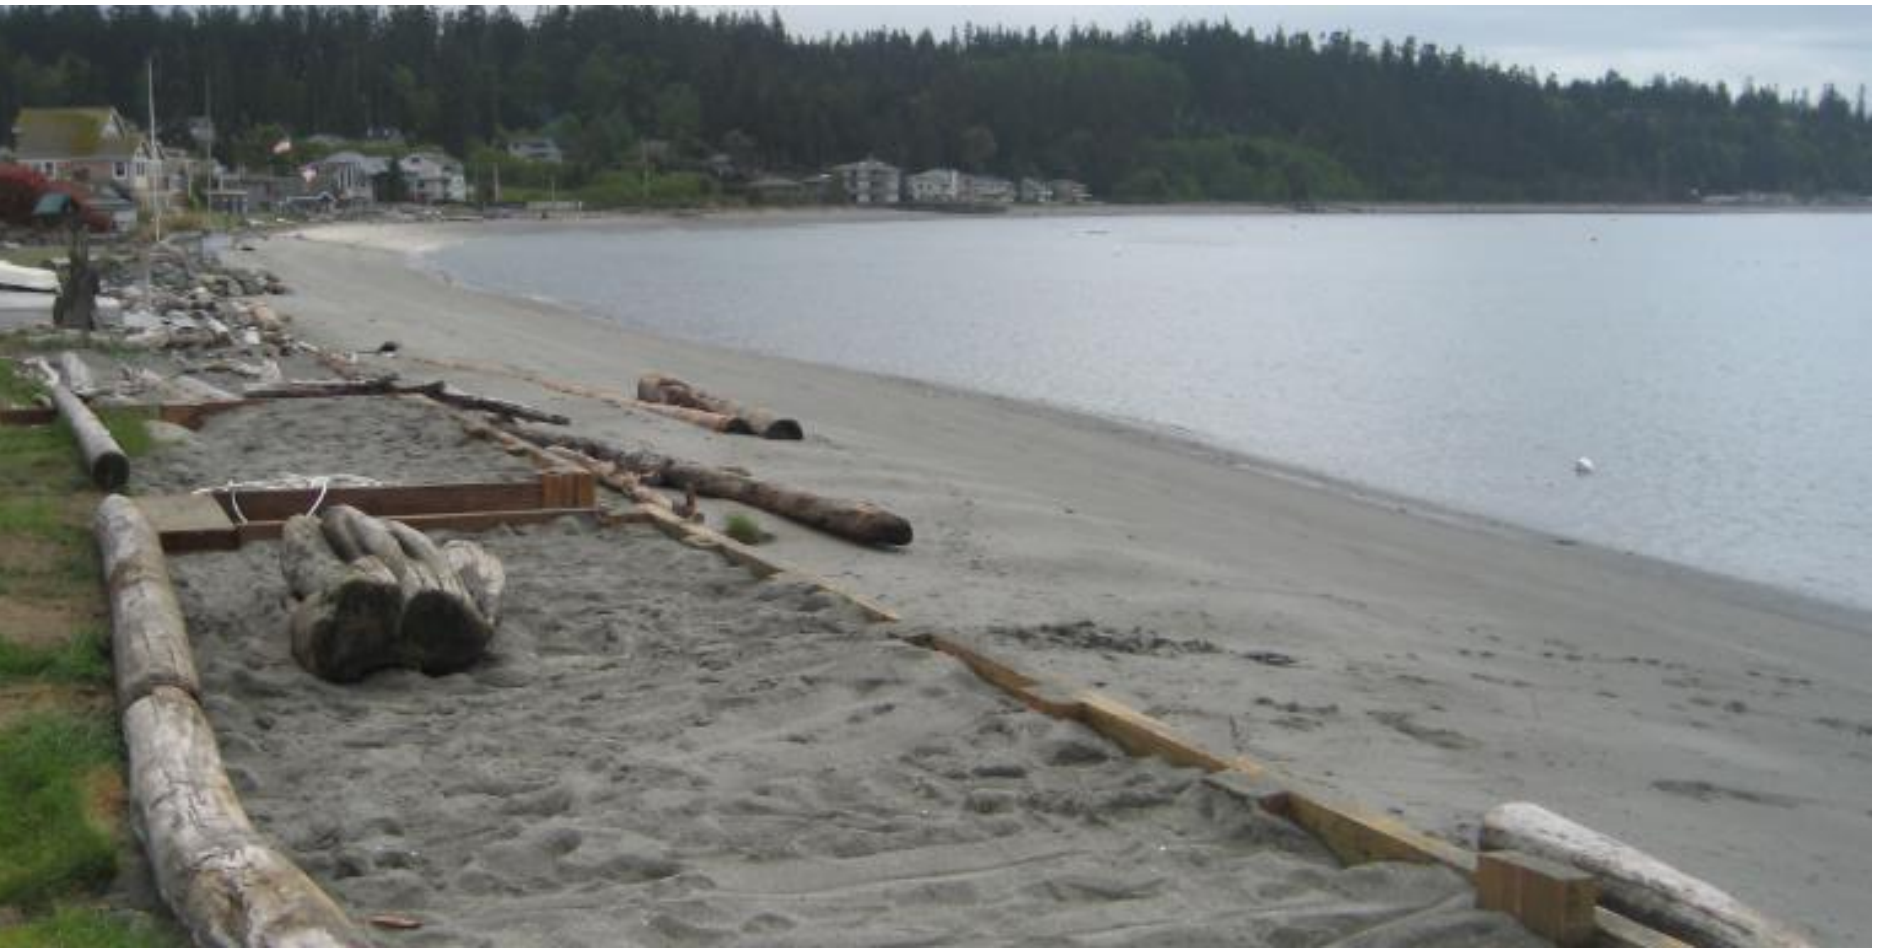
View of the beach 2008 – pristine sand beach and the crescent shape of the bay

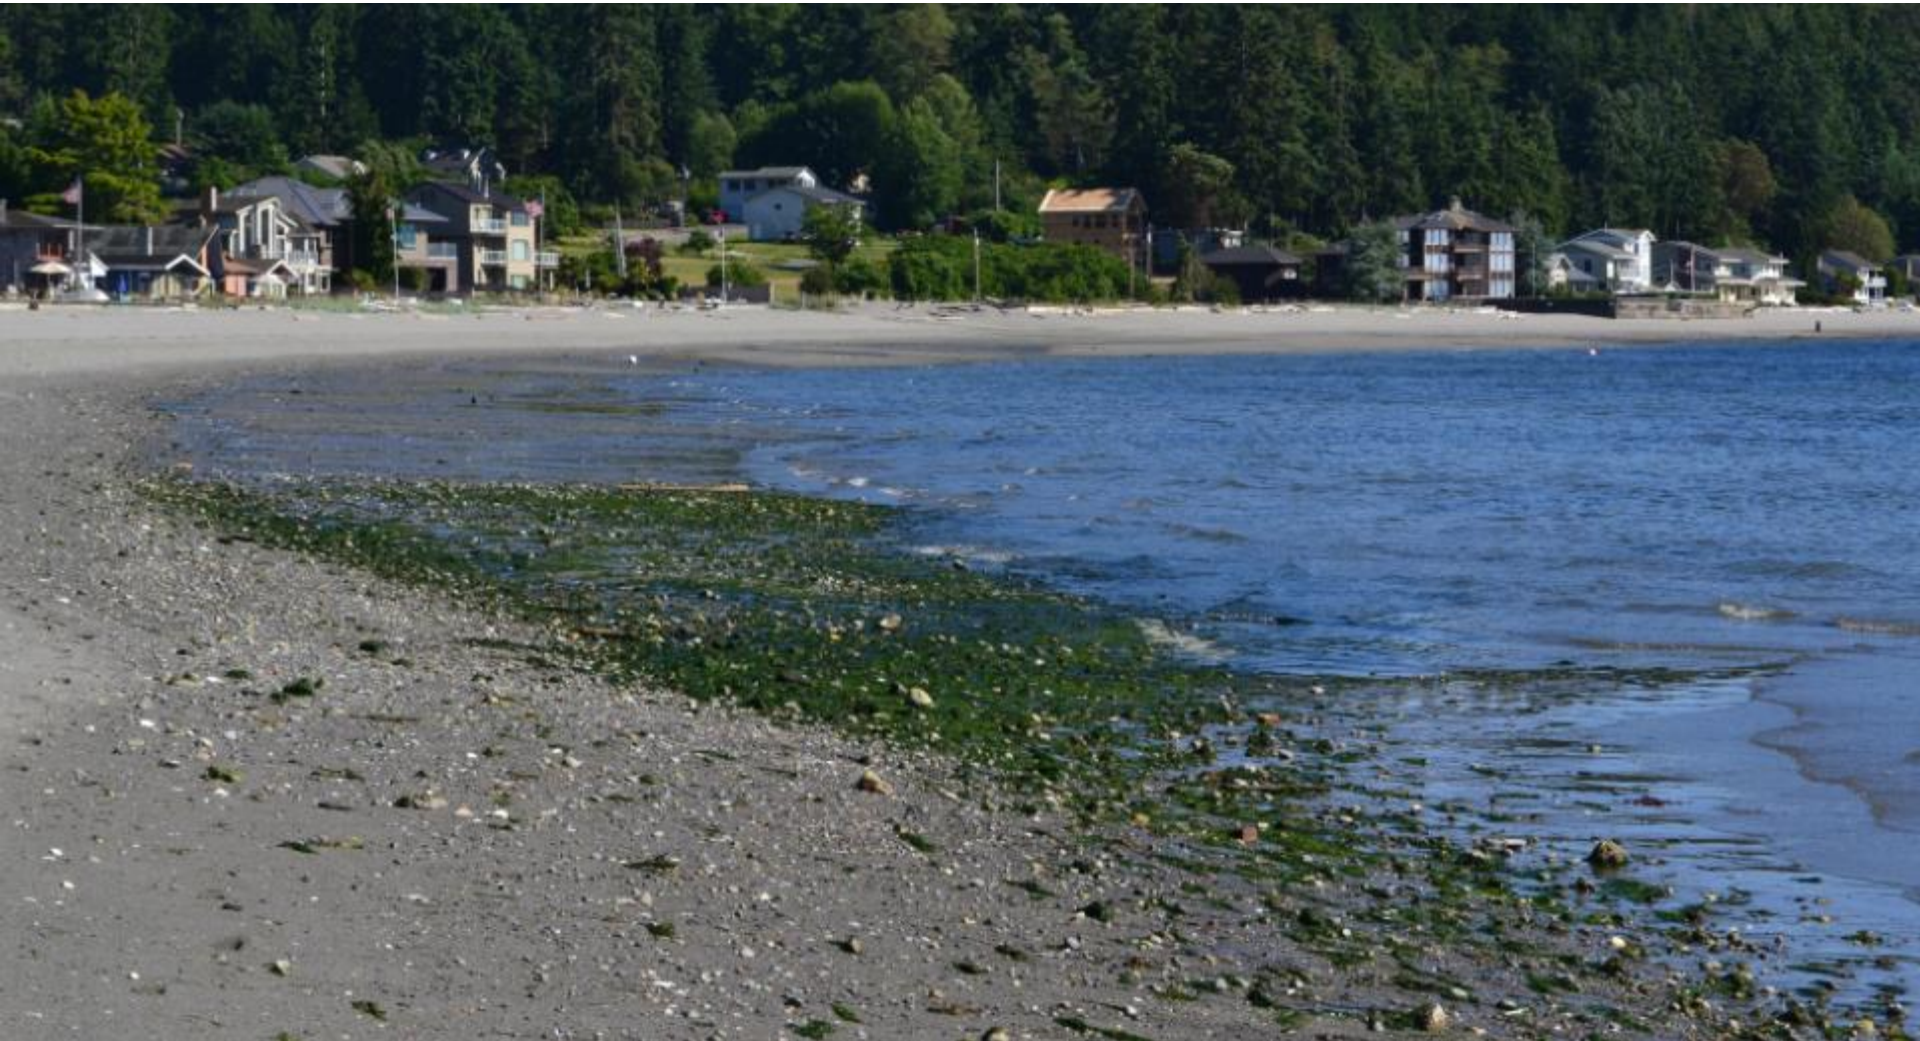
for those that have lived along Mutiny bay for 50 years can remember there were only a few rocks before the tide flats. That has changed, the quantity of exposed rocks are many – giving credence to the presented replenishing sand flows are being stopped and being redirected by the boat ramp sand bar.

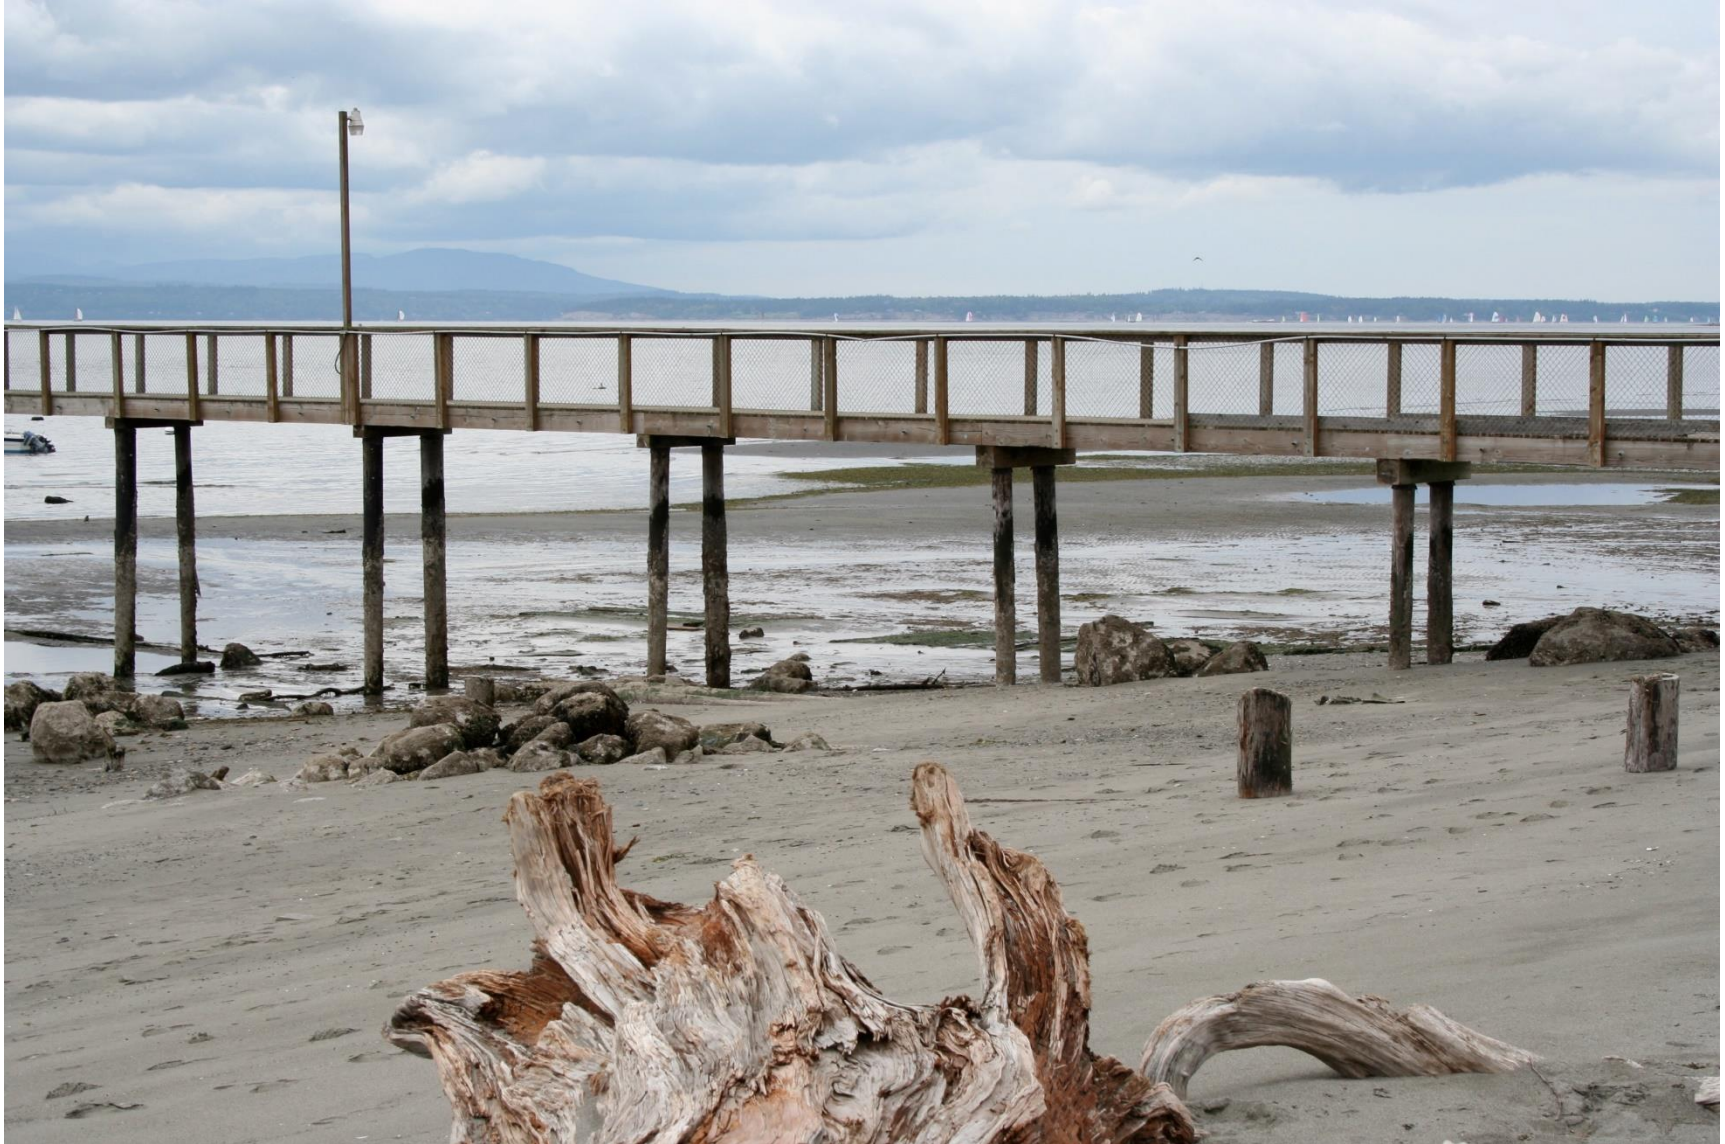
Before

This shows show the extent of the erosion

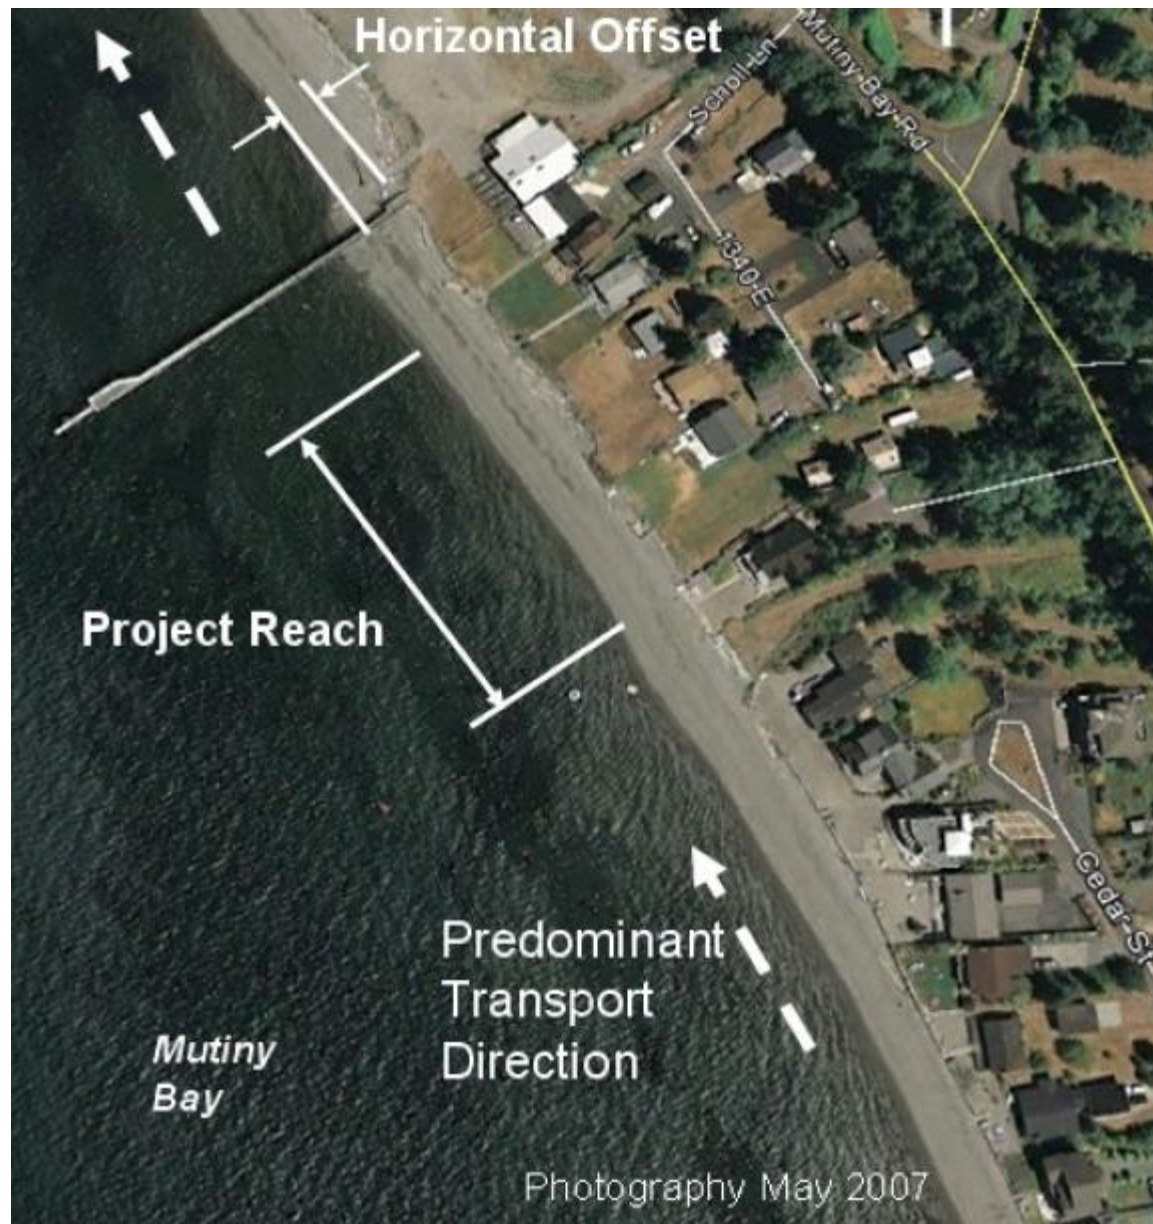
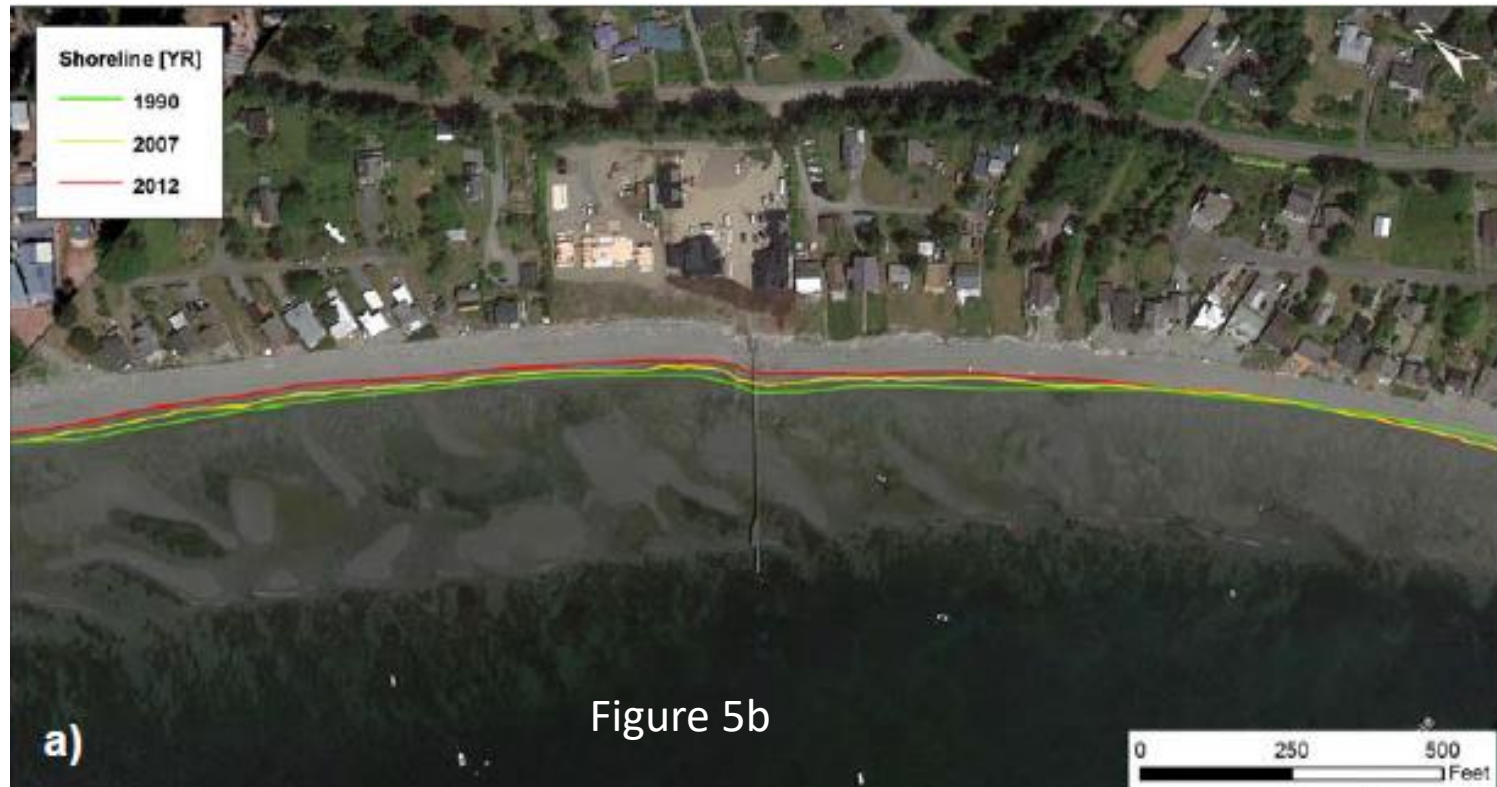
2013 STUDY BY COAST AND HARBOR & ENGINEERING DOCUMENTS EROSION

The software Digital Shoreline Analysis System (DSAS) (Thieler *et al.* 2009) was used for organizing and comparing shoreline position data. Digitized shoreline positions for the years 1990, 2007, and 2012 are plotted by color in Figure 5a. Shoreline position change output by DSAS is plotted in Figure 5b. The figures show that the shoreline retreated about 10 ft. between 1990 and 2007 from near the south end of the project reach to about 1,200 ft. north of the project reach. From 2007 to 2013 the retreat continued another 10 ft. South of the project reach there was approximately no change, to slight shoreline advance.

1990-2007 - 17 years - 10 feet of documented erosion

2007-2013 - 6 years - 10 feet of documented erosion
